Project No. 09-785

# Assessment of Embrittlement of VHTR Structural Alloys in Impure Helium Environments

University of Wisconsin, Madison

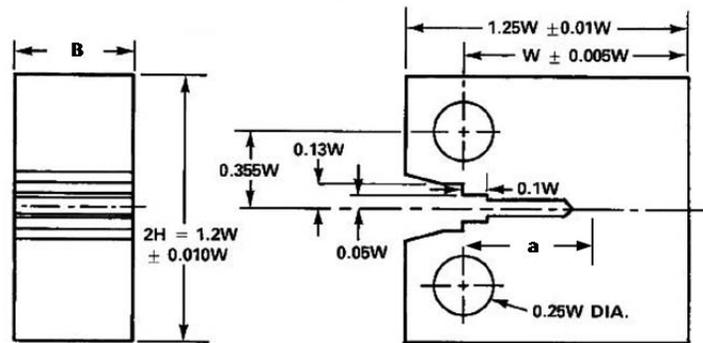
**Figure 1 Geometry of compact tension (CT) specimens as defined by ASTM standard E1457-07. Values of  $W = 50$  mm,  $B = 6.25$  mm, and  $a = 27.5$  mm were chosen for the studies presented herein.**

Compact tension (CT) specimens for the creep crack growth (CCG) experiments were fabricated from the aged alloy materials. Figure 1 presents the CT specimen geometry defined by ASTM standard E1457-07 [1]. After an investigation into the necessary stress levels needed to induce creep crack growth within the candidate alloys, along with a comprehensive evaluation of the anticipated stress levels in the load-bearing components of the CCG testing apparatus, design values of  $W = 50$  mm,  $B = 6.25$  mm, and  $a = 27.5$  mm for the CT specimens were chosen. Electric discharge machining (EDM) was used to fabricate the CT specimens, with the orientation of the crack being aligned with the rolling direction of the samples. Fine-wire EDM was used to machine the final 3.75 mm length of the crack at a width of  $\sim 100$   $\mu\text{m}$ .

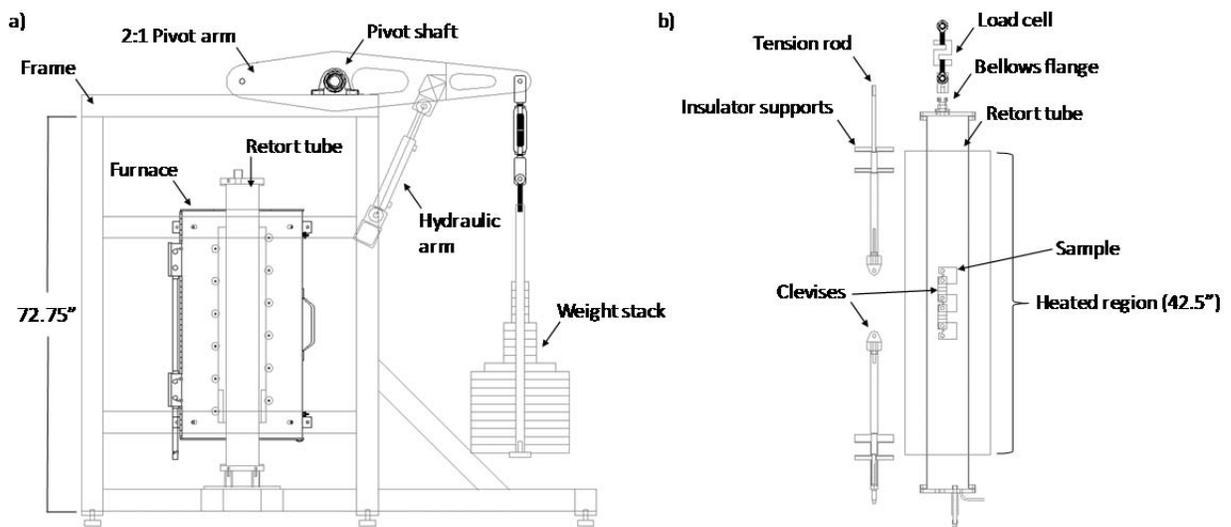
**Figure 3 (a) Schematic of the creep crack growth apparatus. (b) Schematic of the retort tube, highlighting the placement of the three compact tension specimens within the tube. The tension rods (shown outside the retort tube) are connected via the clevises and pins (not shown) to the samples (shown inside the retort tube) during testing.**

A 2:1 ratio pivot arm positioned above the chamber (Figure 3a), which connects to the load rod on one side and a weight stack on the other, provides a means for both applying a vertical load to the specimens as the load assembly translates vertically and reducing the overall mass required (a 2:1 reduction) to load the specimens. A hydraulic arm supports the pivot arm when CCG testing is not in progress, and a catch plate (not shown in Figure 3) positioned below the weight stack provides a soft base for absorbing the impact of the weight stack should a CT specimen fail rapidly.

A bellows flange (Figure 3b), which provides a seal with inches of allowable travel to accommodate vertical translation of the tension rods (e.g., due to thermal expansion and specimen cracking), was positioned at the top of the tube. As explained in the ASTM standard, real-time monitoring of crack growth within each CT specimen is performed using the direct current potential drop technique; therefore access ports for electrical wires for DCPD monitoring were included at the top of the tube (not shown). Additionally, access ports for a thermocouple and gas inlet/outlet lines were included (also not shown). A three-zone, 1200 °C maximum temperature split-tube furnace (Thermcraft Inc., Winston-Salem, NC) surrounds the majority of the environmental chamber, providing uniform temperature control. Insulator supports, fabricated with Inconel 600, are attached to the tension rods to provide thermal barriers above and below the CT specimens.

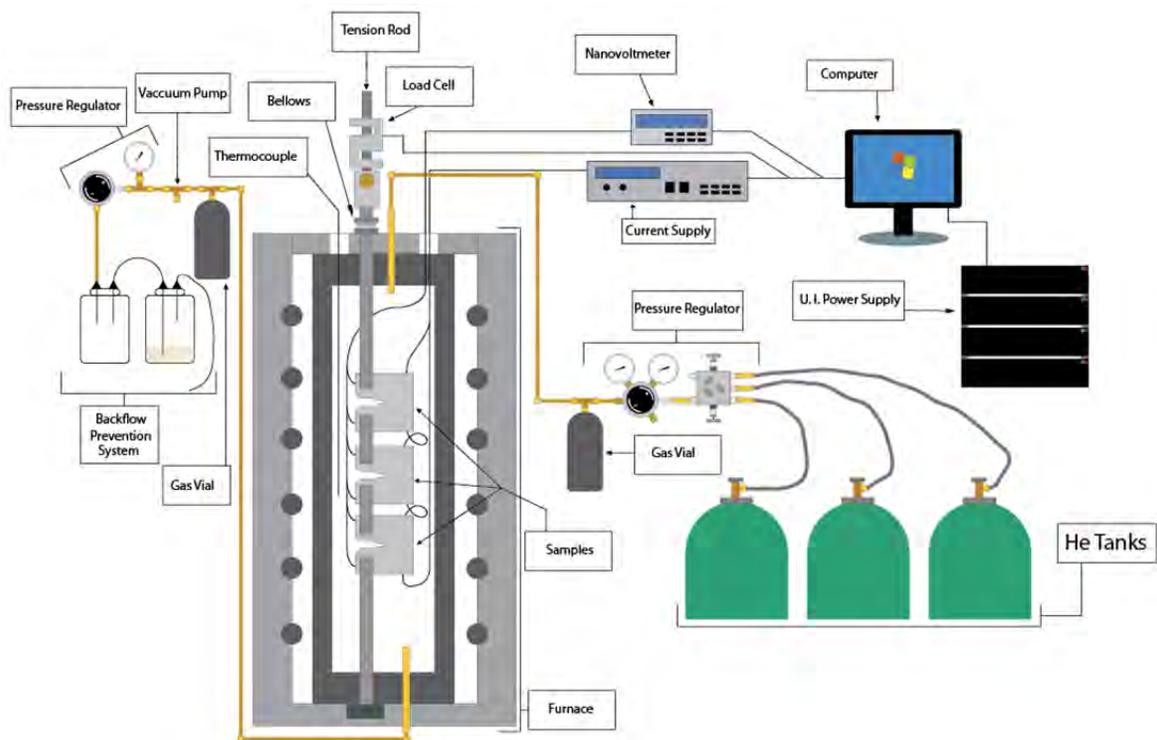
**Figure 4 Idealized schematic depicting the key components of the creep crack growth (CCG) testing system.**

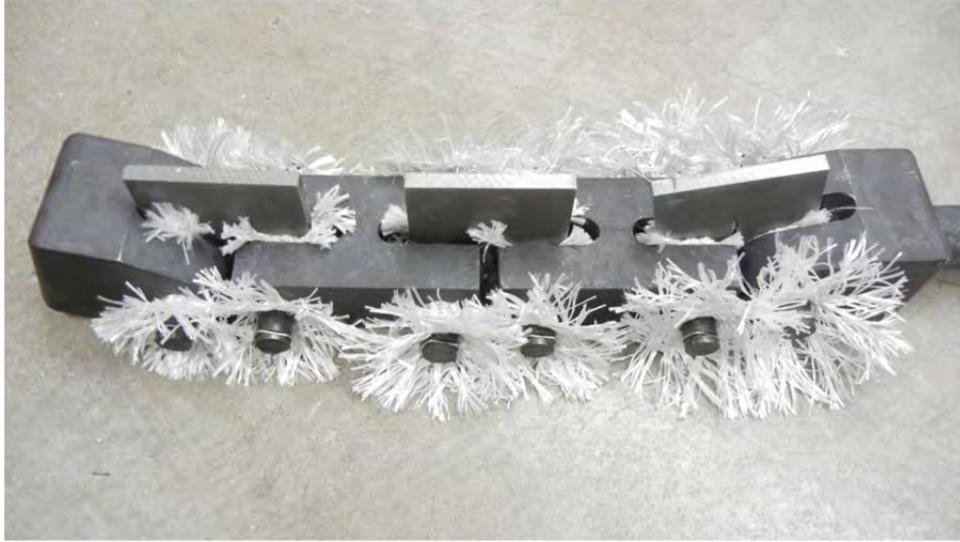
**Figure 5** Image of three CT specimens mounted in the clevises prior to CCG testing (electrical wiring not shown). The braided ceramic sleeving that surrounds the pins and electrically isolates the samples from the clevises.

An image of three CT specimens mounted before testing is presented in Figure 5. The image was taken before the electrical wiring was welded to the specimens. Braided ceramic sleeving for electrically isolating the specimens from the clevises can be seen. In the orientation shown, the precracks in the CT specimens are facing down.

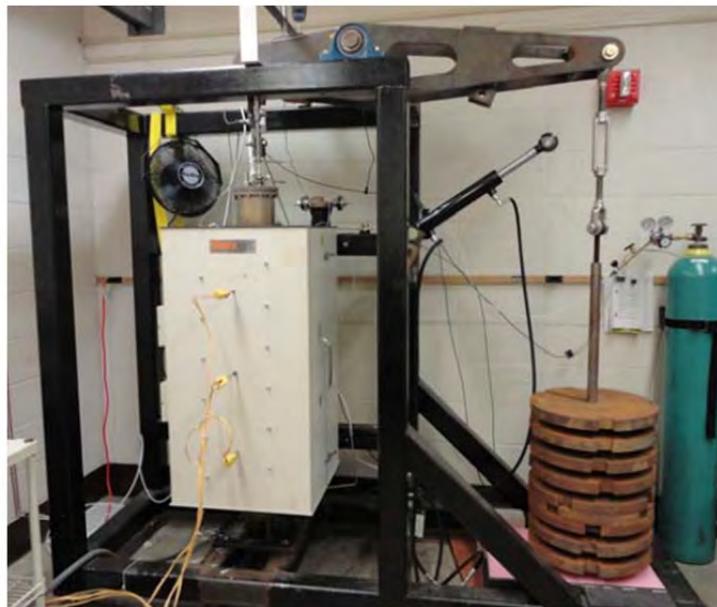
**Figure 6** Image of the creep crack growth testing apparatus, shown loaded with 9 steel plates (100 lbs per plate).

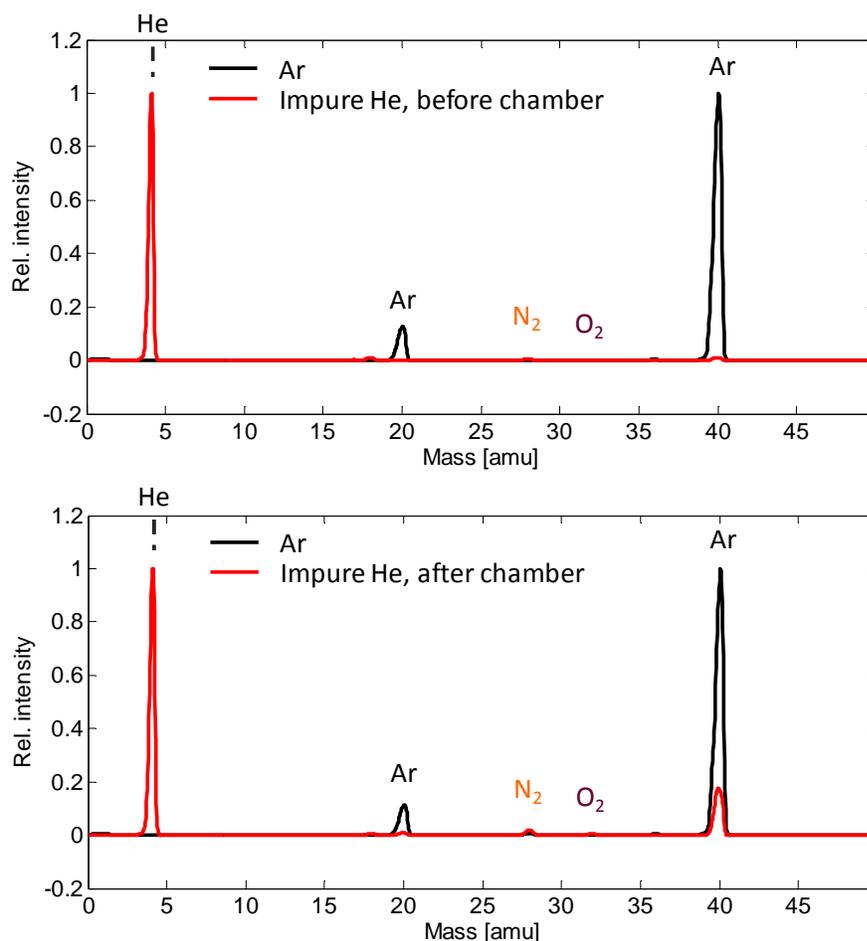
**Figure 7** Mass spectra of impure He gas extracted from the flow lines before (top) and after (bottom) entering the CCG chamber. Argon spectra are present as a reference. Argon peaks in the He spectra are due to argon in the lines of the mass spectrometer.

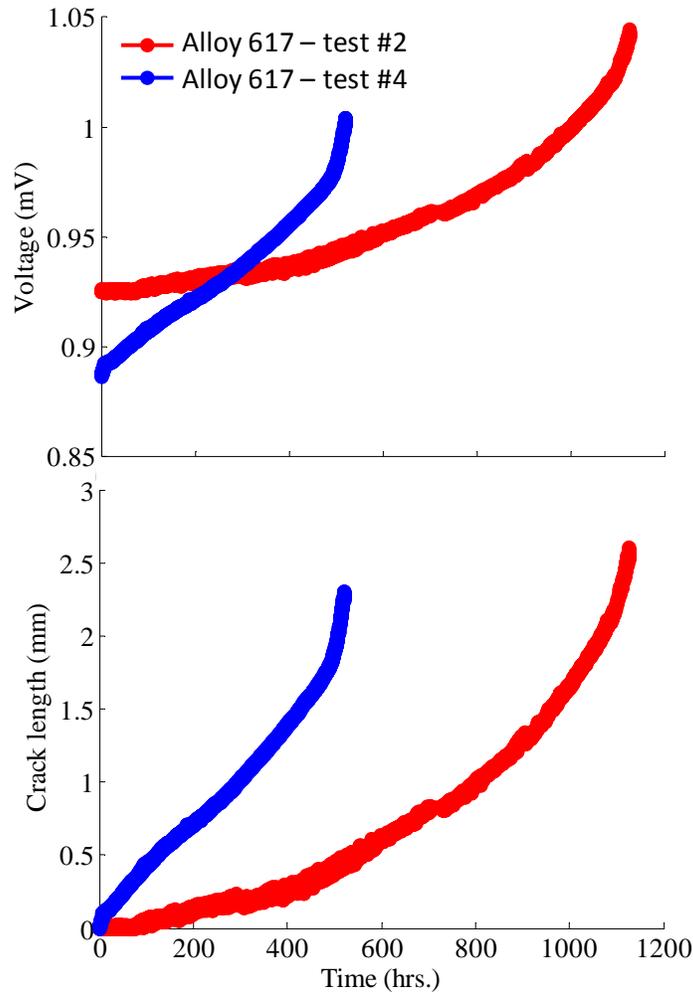
**Figure 8 DCPD data (top) and calibrated crack length-data (bottom) to demonstrate the conversion of voltage signals to crack lengths during CCG testing.**

Initial validation of the DCPD technique involved using EDM machining to cut precracks of various lengths into stainless steel samples and then using Equation (1) to predict the length of the precrack. Initial results indicated good agreement (e.g., errors on the order of 5%) between the predicted and the known values. During CCG testing, Equation (1) was applied to the DCPD data in real time to approximate the crack length continuously. After each CCG test was completed, measurement of the final crack length was performed using SEM imaging, and the crack-length data were corrected to reflect the true crack length as a function of time. Once the voltage signals were converted into accurate crack measurements, determination of the crack growth rate,  $da/dt$ , was done using custom Matlab scripts by smoothing the DCPD data and then calculating the slope of the crack length versus time data using the point-to-point technique. Figure 8 presents two example cases that demonstrate the conversion of DCPD voltage signals into crack-length measurements.

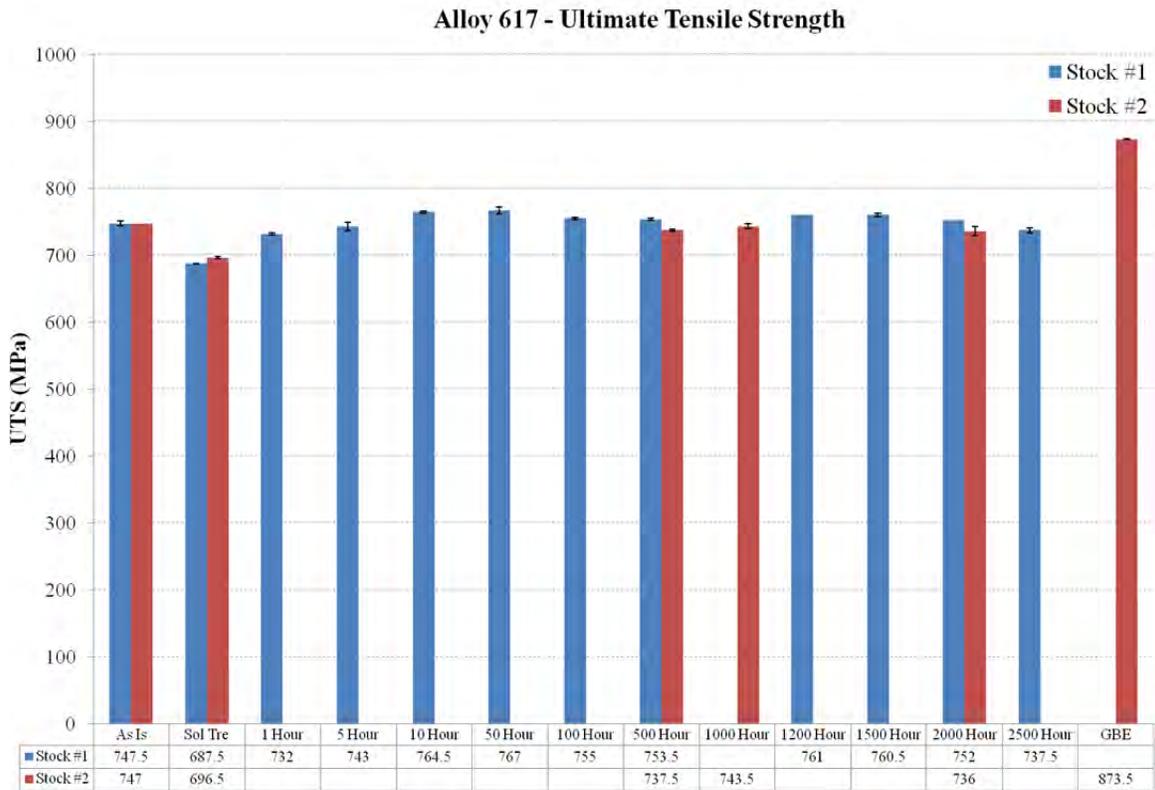
**Figure 10** Ultimate tensile strength results for Alloy 617 samples as a function of aging time. Results for the GBE samples are plotted on the right side of the graph.

Good correlation is observed between the trends of the UTS and  $\sigma_Y$  plots, with the variations in  $\sigma_Y$  being more apparent as a function of aging time. The % elongation results from 1 hour of aging and beyond follow a similar trend (the results for % elongation from the as-received and solution-treated samples are higher than the rest and thus do not follow the pattern). No obvious trend exists for hardness as a function of aging, with the majority of the measured values falling within the error bars of the others. The GBE samples exhibit superior properties (UTS,  $\sigma_Y$ , and Hv), with its value for % elongation at failure only being smaller than those of the as-received and solution-treated samples.

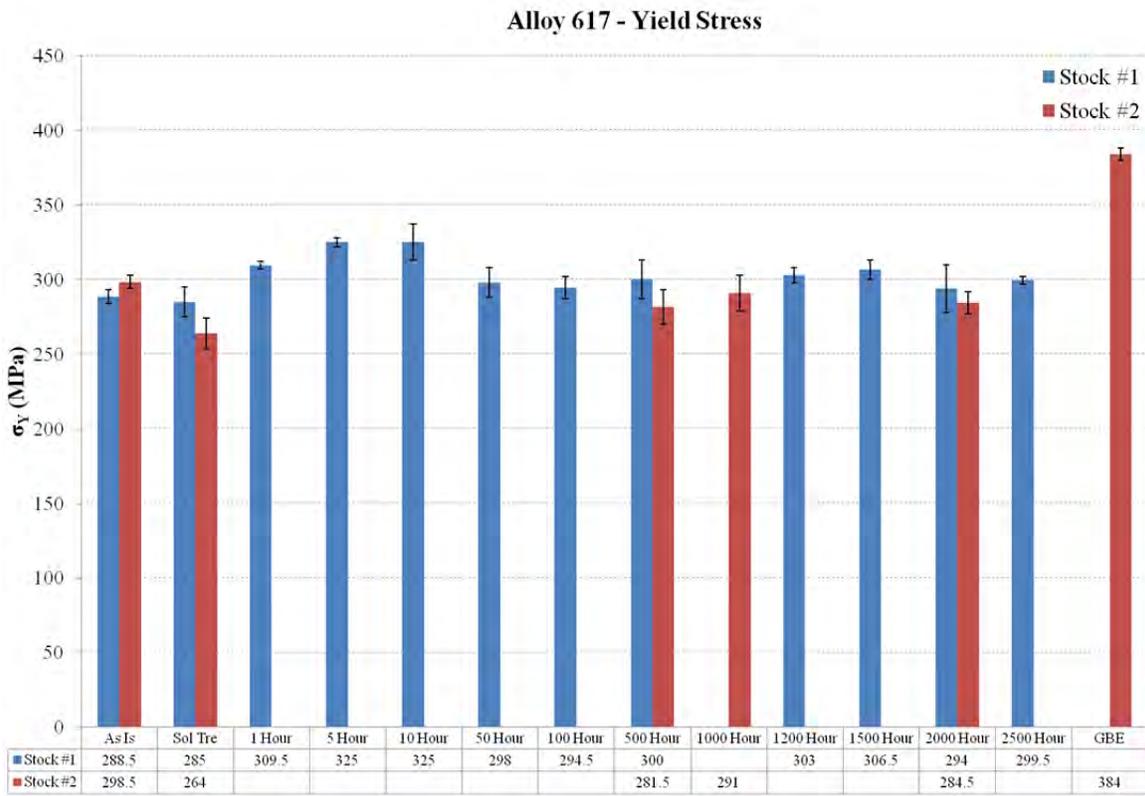
**Figure 11 Yield stress results for Alloy 617 samples as a function of aging time. Results for the GBE samples are plotted on the right side of the graph.**

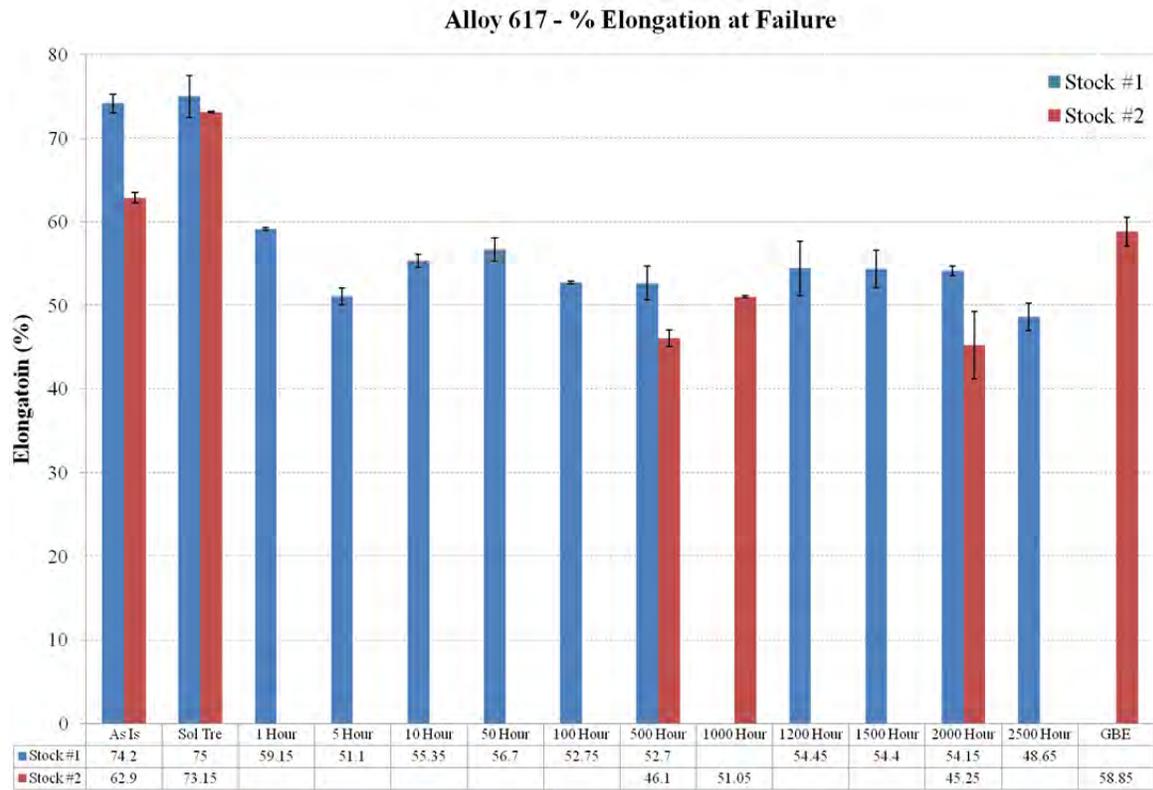
**Figure 12 Results for % elongation at failure for Alloy 617 samples as a function of aging time. Results for the GBE samples are plotted on the right side of the graph.**

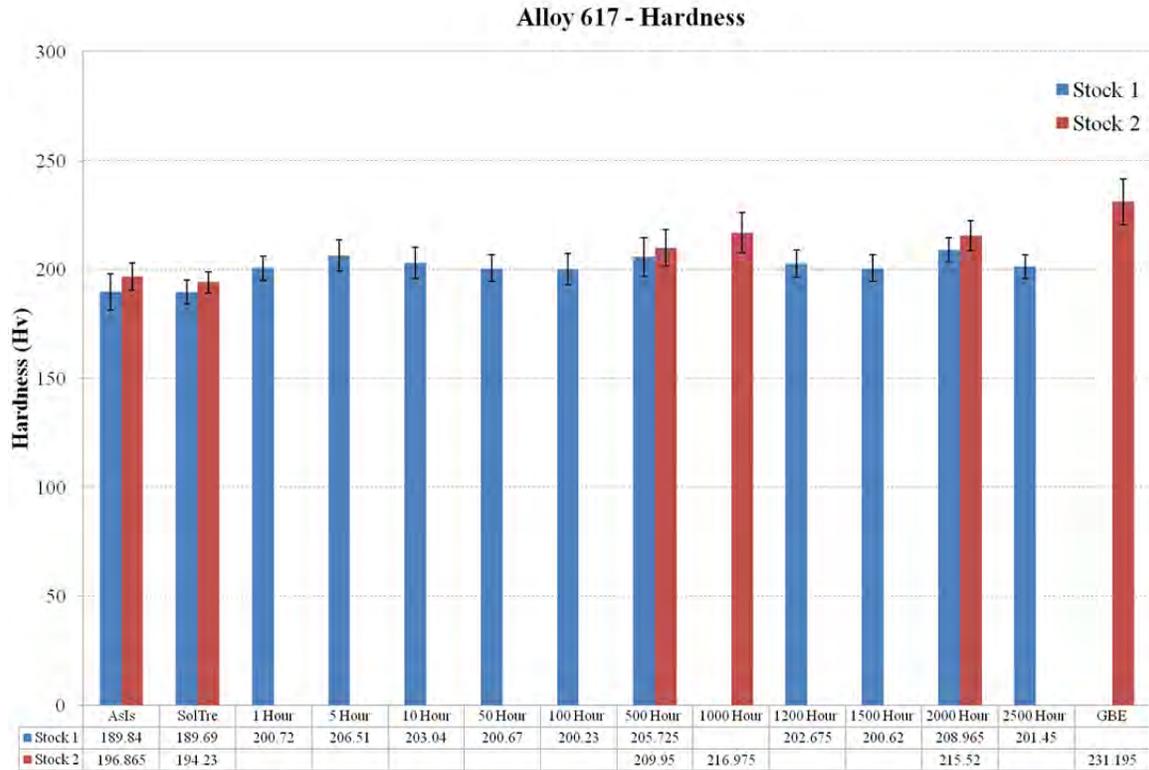
**Figure 13 Results for hardness of Alloy 617 samples as a function of aging time. Results for the GBE samples are plotted on the right side of the graph.**

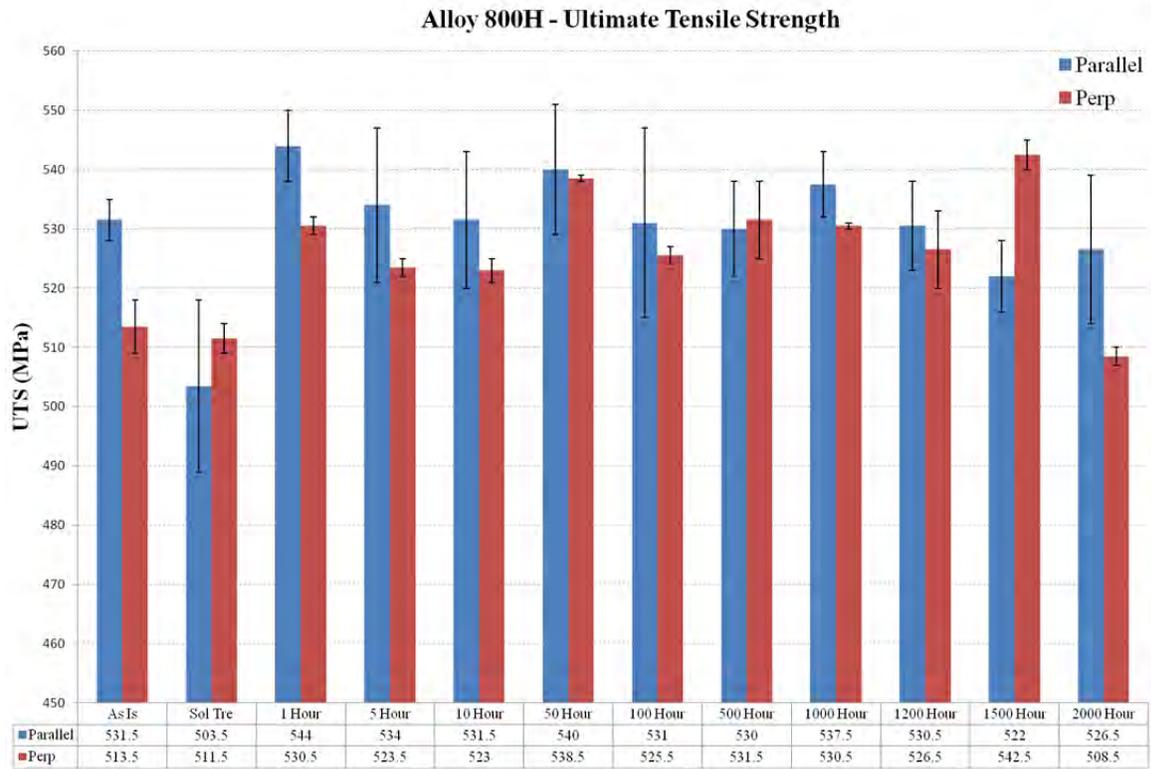
**Figure 14** Ultimate tensile strength results for Alloy 800H samples as a function of aging time.

Figure 14, Figure 15, and Figure 16 present the ultimate tensile strength (UTS), yield stress ( $\sigma_Y$ ), and % elongation at failure for the Alloy 800H samples as a function of aging time. Figure 17 presents the hardness results for the Alloy 800H samples. Tensile property results for samples aligned both parallel and perpendicular to the rolling direction were measured to investigate possible anisotropy in mechanical properties due to the rolling process.

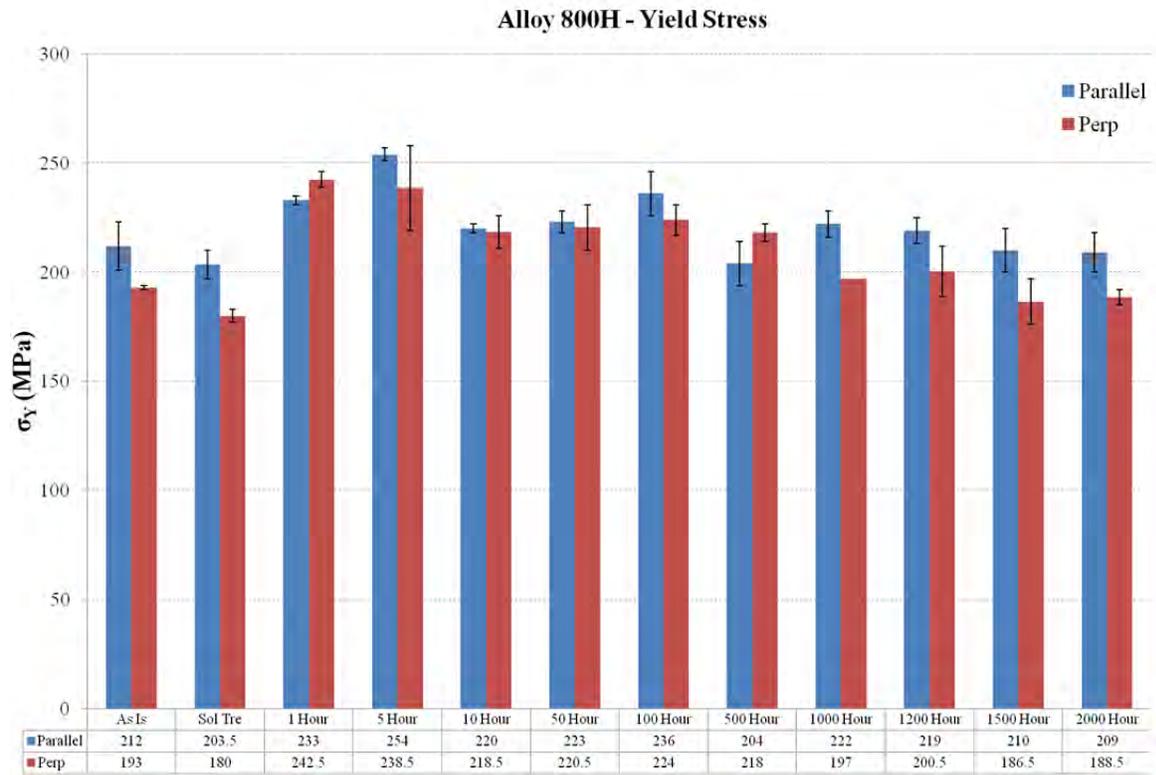
**Figure 15 Yield stress results for Alloy 800H samples as a function of aging time.**

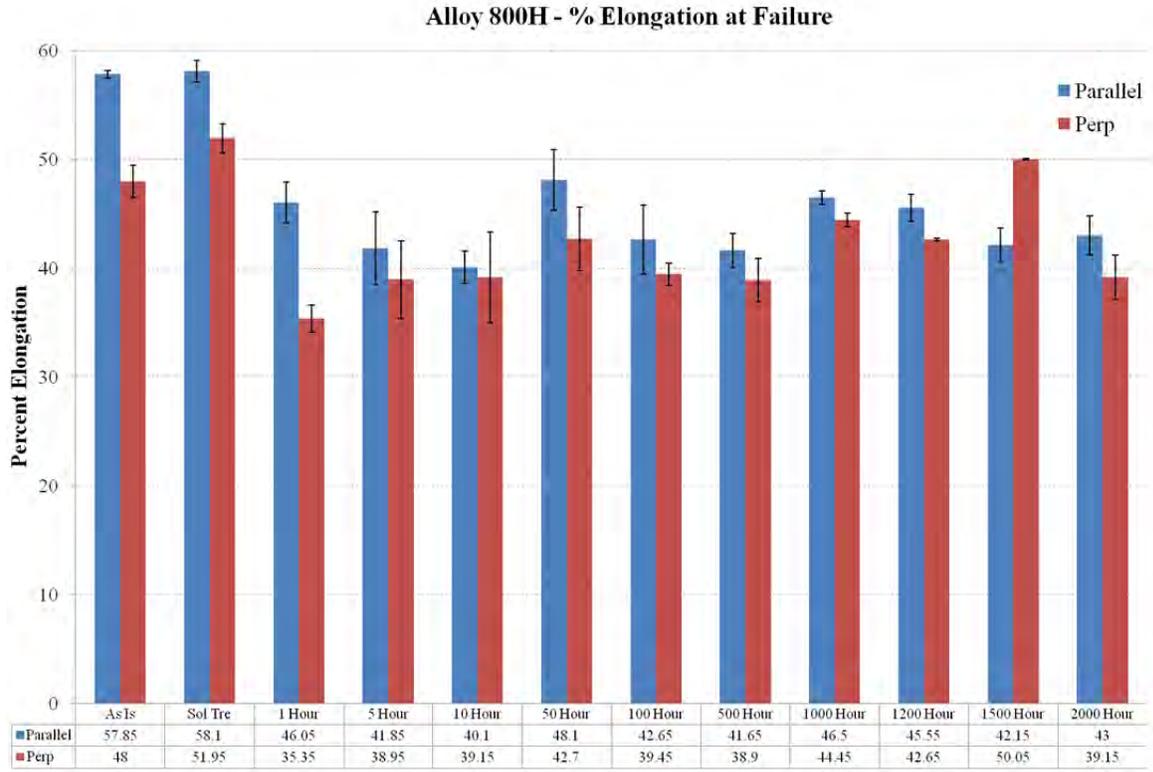
**Figure 16 Results for % elongation at failure for Alloy 800H samples as a function of aging time.**

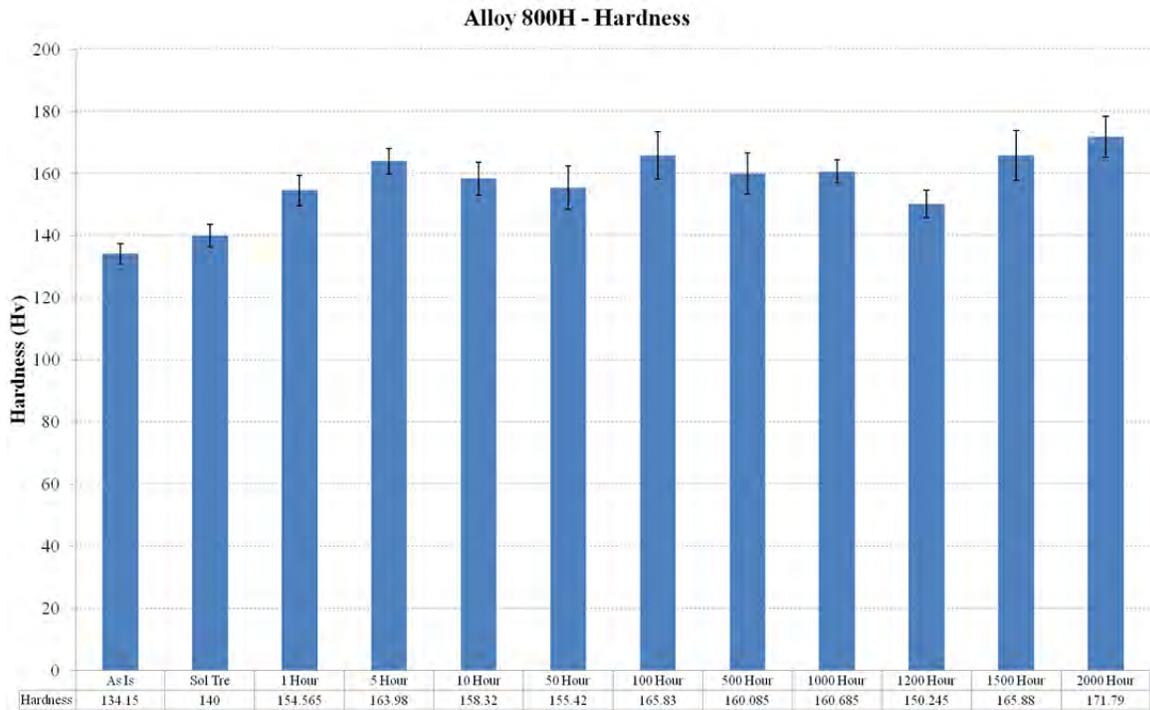
**Figure 17 Results for hardness of Alloy 800H samples as a function of aging time.**

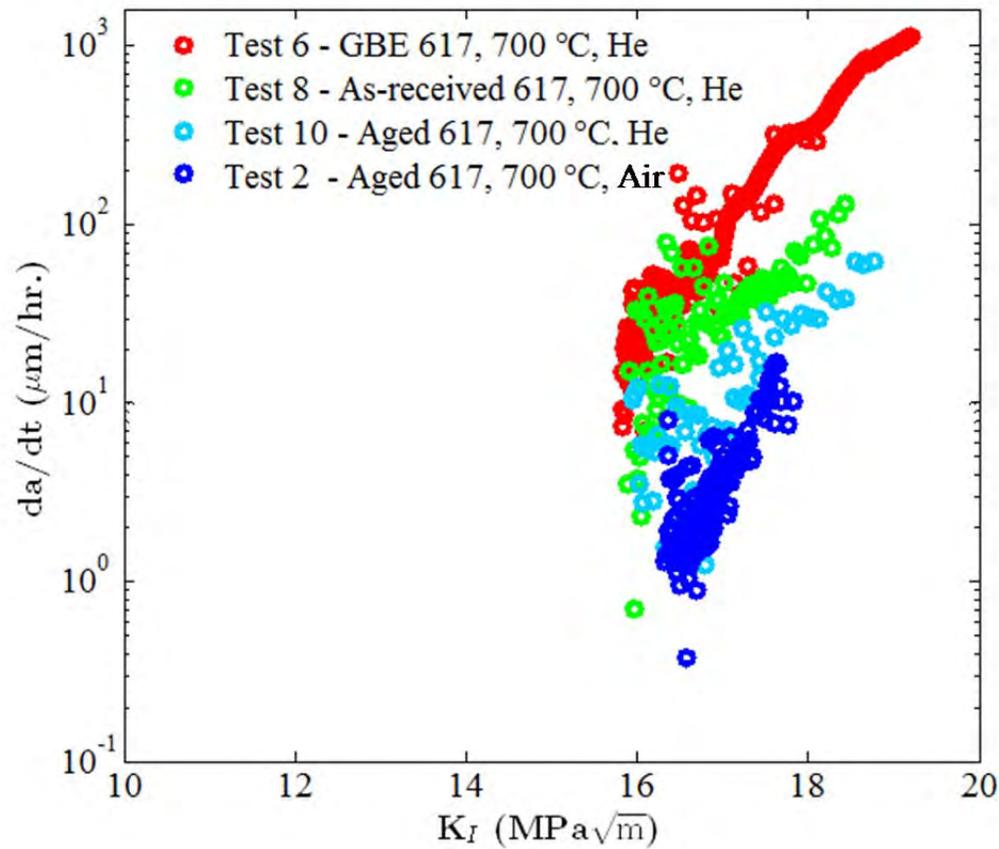
**Figure 18 CCG results for Alloy 617 tested at 700 °C.**

The CCG results from the Alloy 617 samples tested at 700 °C are presented in Figure 18. Results for  $da/dt$  versus  $K_I$  for the 617 samples tested at 700 °C reveal that aged Alloy 617 samples tested in air at exhibit the highest resistance to crack growth, followed the aged 617 samples tested in He, followed by the as-received 617 samples tested in helium, followed by GBE samples tested in helium.

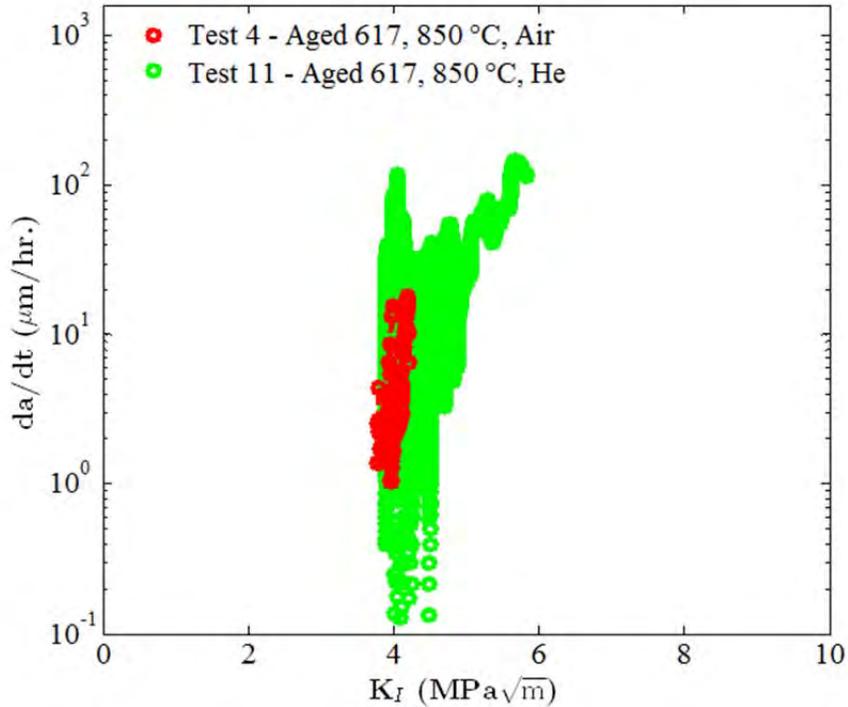
**Figure 19 CCG results for Alloy 617 tested at 850 °C.**

The CCG results from the Alloy 617 samples tested at 850 °C are presented in Figure 19. The aged 617 samples tested 850 °C show a dramatic reduction in resistance to crack growth compared to the samples tested at 700 °C (e.g.,  $K_I \approx 4 \text{ MPa}\sqrt{m}$  gives rise to crack growth at 850 °C, whereas  $K_I > 15 \text{ MPa}\sqrt{m}$  is required to induce cracking at 700 °C). At 850 °C, the crack-growth resistance appears to be slightly better in the He environment, although the early spike in  $da/dt$  around  $K_I \approx 4 \text{ MPa}\sqrt{m}$  (only measured in one of the samples tested in He) indicates that the crack growth rate accelerated initially but then slowed as that test progressed. Comparing the results from 700 °C and 850 °C, the significant reduction in the crack growth resistance of the 617 samples tested at the higher temperature is correlated with the known dramatic reductions in creep resistance and strength, both of which likely lead to the pronounced reduction in crack growth resistance.

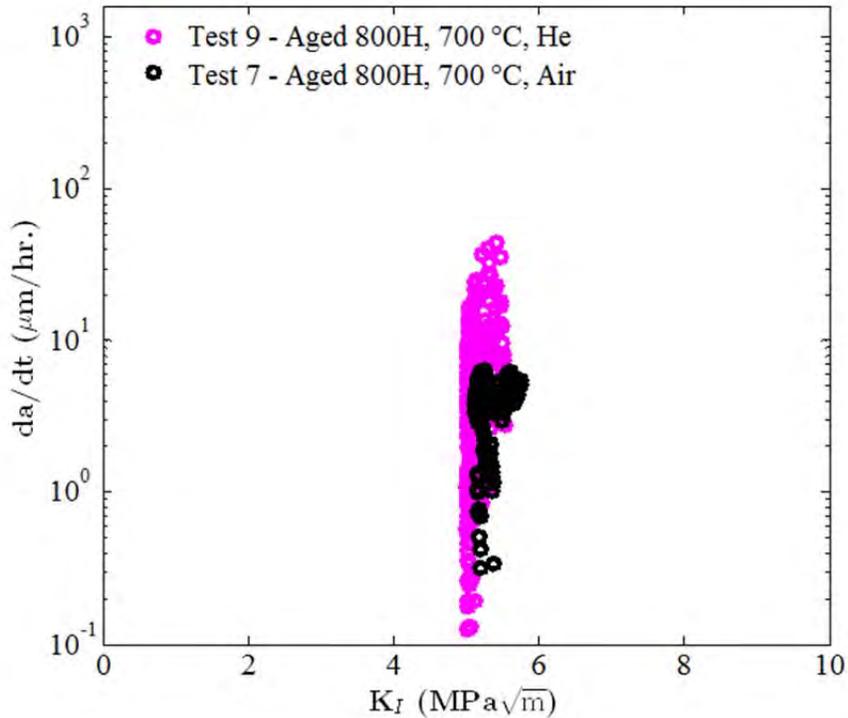
**Figure 20 CCG results for Alloy 800H tested at 700 °C.**

The CCG results from the Alloy 800H samples tested at 700 °C are presented in Figure 20. The 800H samples tested in air at 700 °C exhibit a resistance to crack growth that is substantially worse than all results obtained from the 617 samples tested at 700 °C, with performance that is only marginally better than that of the 617 samples tested at 850 °C (e.g.,  $K_I \approx 5 \text{ MPa}\sqrt{m}$  produces crack growth in Alloy 800H tested at 700 °C, whereas  $K_I \approx 4 \text{ MPa}\sqrt{m}$  produces cracking in Alloy 617 at 850 °C). The crack-growth resistance for 800H appears to be slightly better in the air environment as compared to He. The inferior CCG performance of Alloy 800H is correlated with the inferior mechanical properties measured and discussed above in Section 3.1.

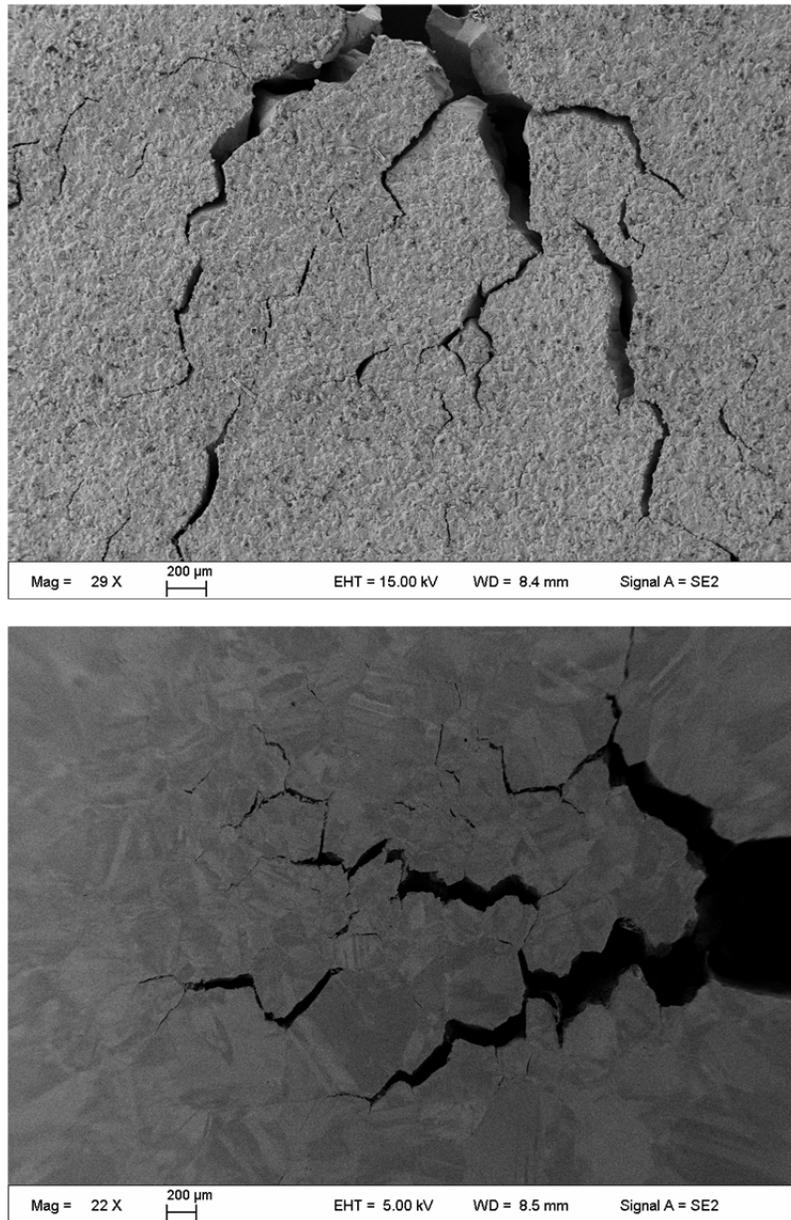
Figure 21 shows example SEM images of the cracks formed on the outer surface and central plane of a CT specimens after creep crack growth testing. Many crack branches are readily observed. After cutting the CT specimens in half, it was found in all cases that cracks within the interior of the specimens were longer than those found on the surface. Observations of fracture surfaces of the samples (presented below) also confirmed this. As was mentioned in Section 3.2 above, the length of the longest crack within the interior of each specimen was used to quantify crack growth during CCG testing.

**Figure 21 Example SEM images of a sample's outer surface (top) and central plane (below) after creep crack growth testing.**

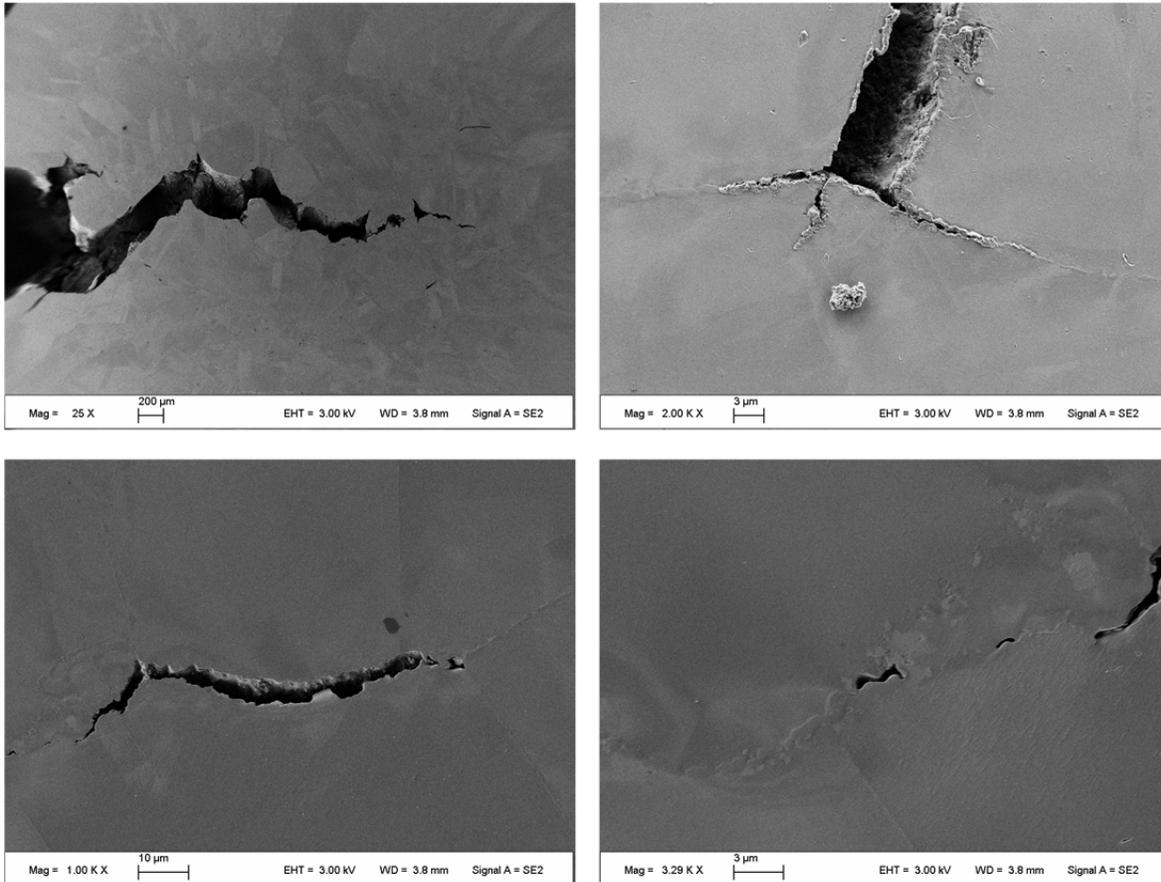
**Figure 22 Crack, crack tip, crack cavitation, and crack initiations in Alloy 617 tested in air at 700 °C (Test 2). The cracks initiated and propagated along grain boundaries. The cracks appeared to have initiated at the grain triple points and at the carbide areas.**

Figure 22 and Figure 23 present SEM images of the crack morphologies of Alloy 617 tested at 700 °C in air and in helium, respectively. One major crack is observed in samples tested in air. There are many small crack branches in samples tested in helium. In both cases, some small crack initiations and/or cavitations are observed in front of the crack tip. In Figure 22, crack propagation along the grain boundaries can be seen. It appears that the cracks initiated primarily from the triple point grain boundary junctions and the carbide regions.

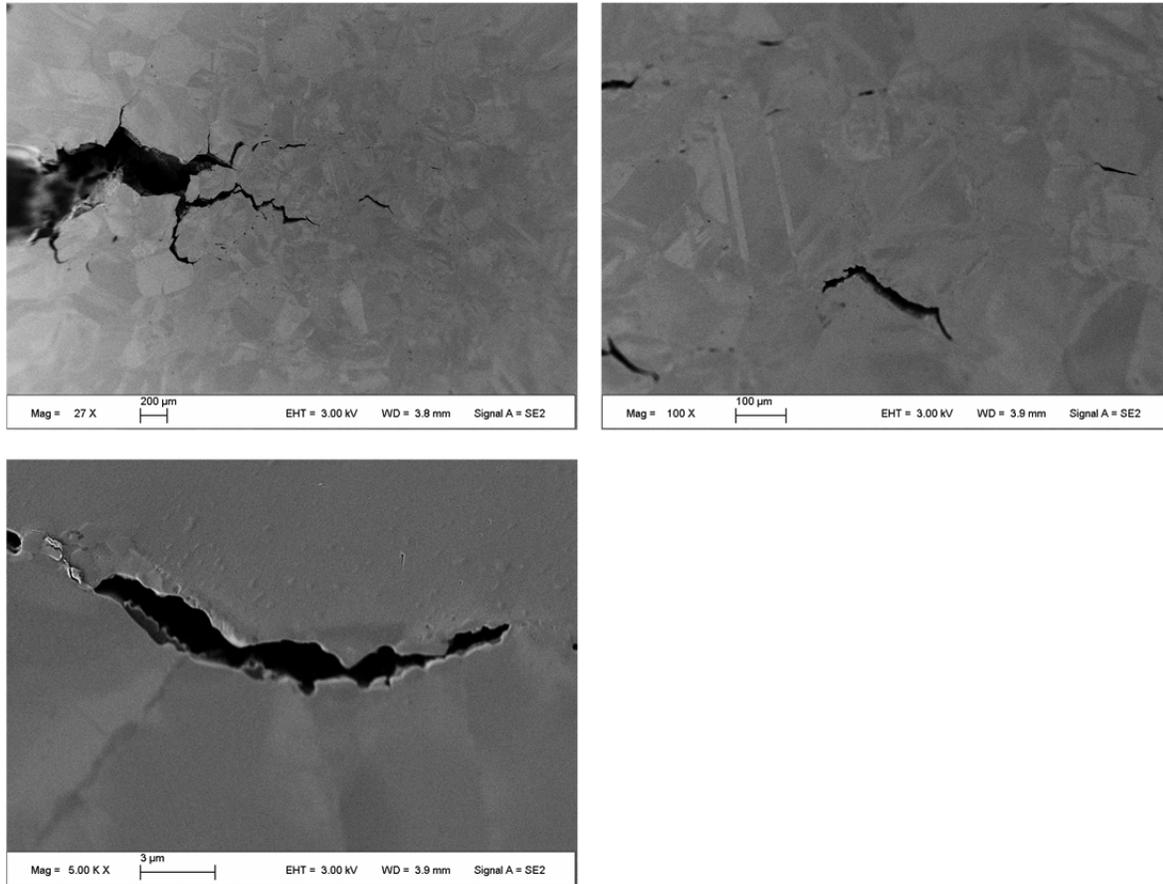
**Figure 23 Cracks in Alloy 617 tested at 700 °C in helium (Test 10). Cracks are intergranular and appear to have initiated at triple points.**

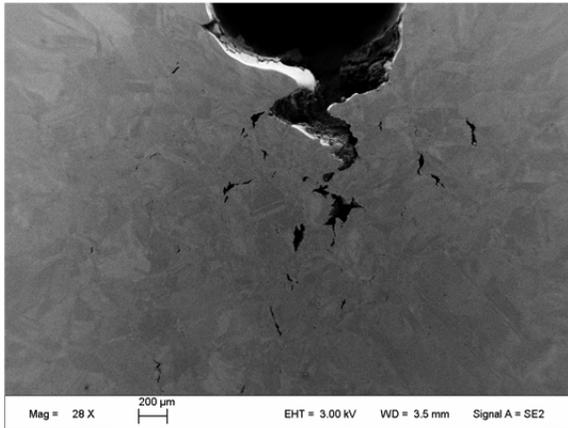
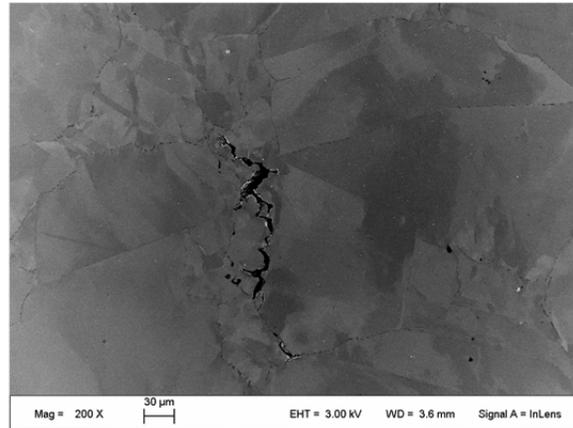
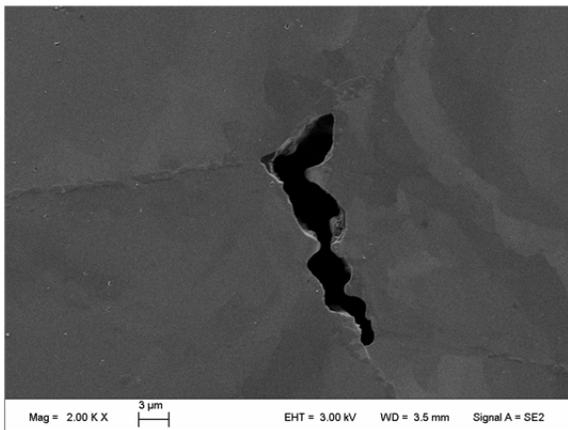
**Figure 24 Cracks in Alloy 617 tested at 850 °C in air (Test 4). Many small cracks are observed. Cracks are intergranular, and cracks appear to have initiated from the triple points and carbide regions.**

Figure 24 and Figure 25 present SEM images of the cracks from Alloy 617 tested at 850 °C in air and helium, respectively. The crack morphologies appear to be similar to one another; namely, there is one major crack and many small cracks. It can be seen from the saw-shaped cracks in Figure 24 that there is significant strain in Alloy 617 tested in air. In both cases, the cracks are intergranular, and cracks appear to have initiated from the triple point grain boundary junctions and carbide regions.

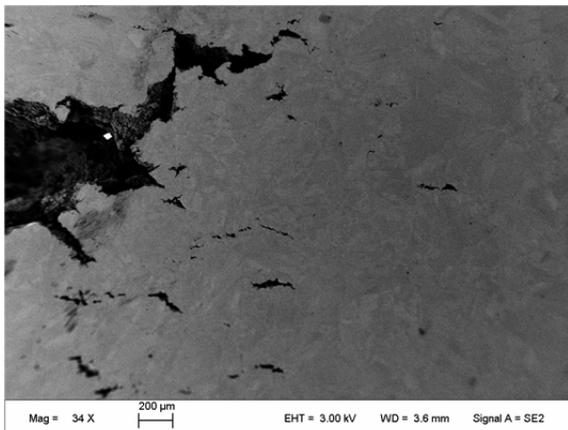
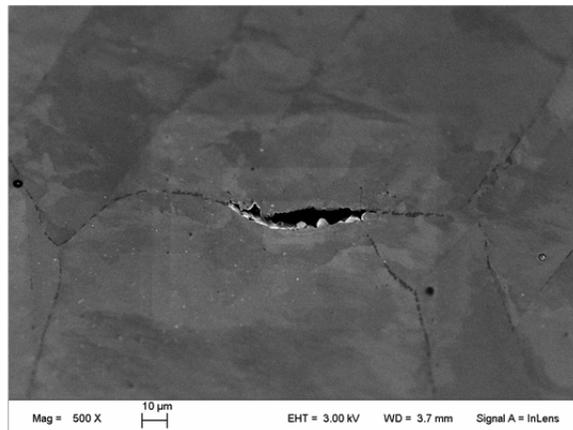
**Figure 25 Cracks in Alloy 617 tested at 850 °C in helium (Test 11).**

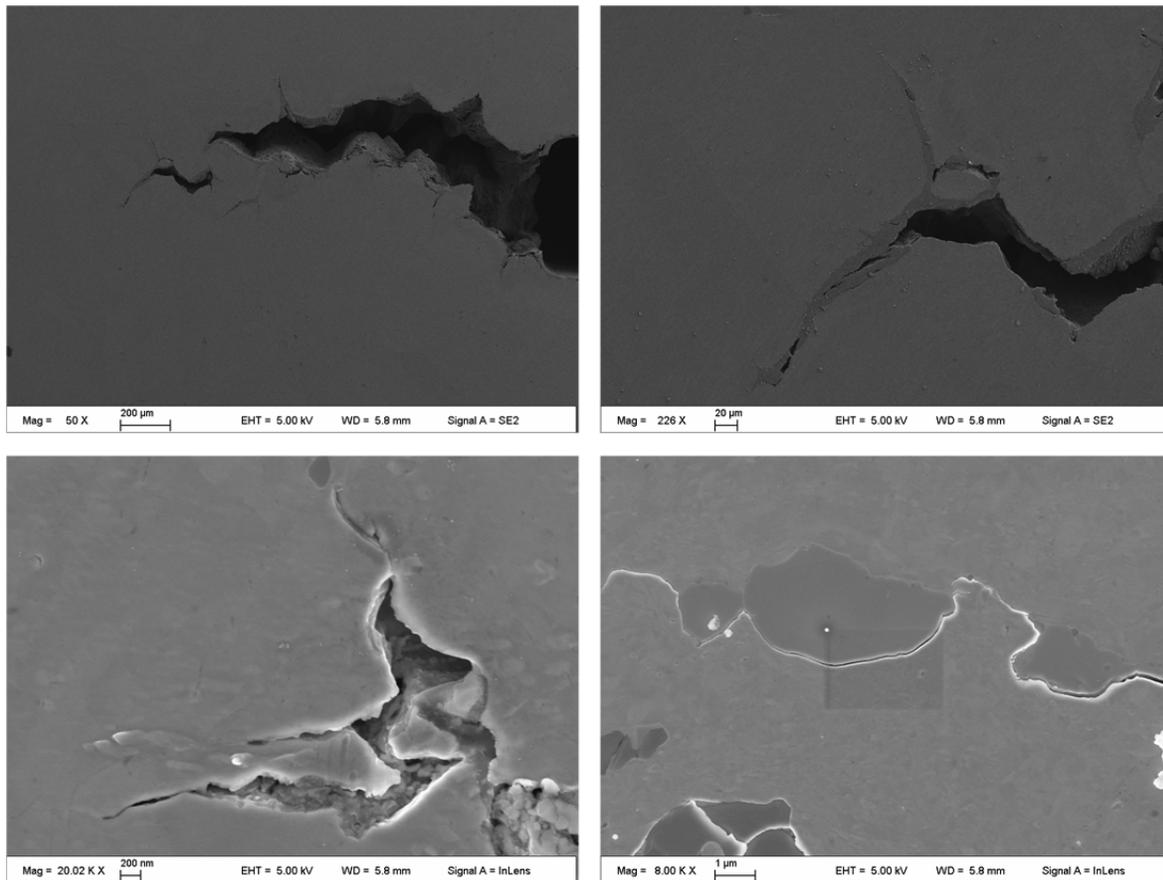
**Figure 26 SEM images of cracks in Alloy 800H tested at 700 °C in air (Test 7). One major crack is seen, and significant oxidation in the crack tip region is observed.**

Figure 26 and Figure 27 presents SEM images of the cracks in the Alloy 800H sample tested at 700 °C in air and in helium, respectively. One major crack is observed in each sample, and the

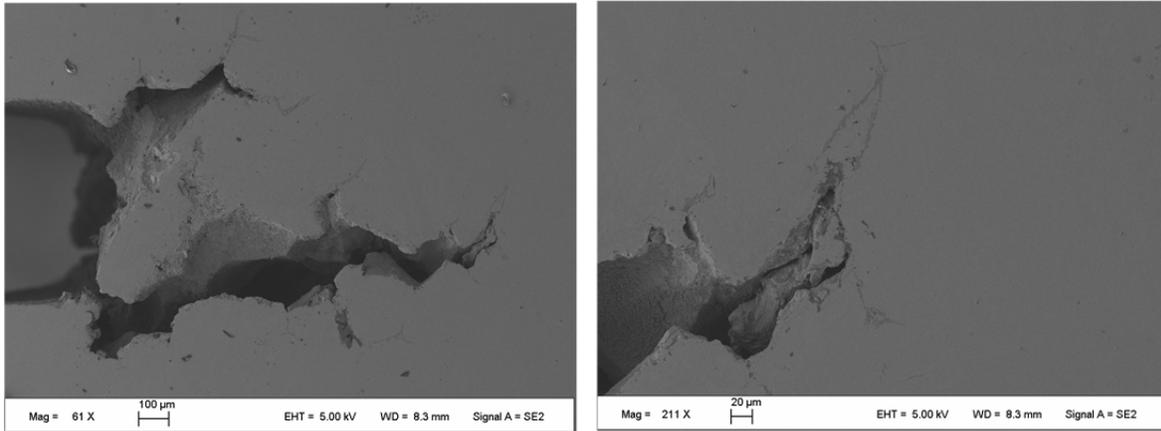
**Figure 27 SEM images of cracks in Alloy 800H tested at 700 °C in helium (Test 9), One major crack is seen, and signs of oxidation in the crack tip and along grain boundary immediately in front of the crack tip are apparent.**
