Project No. 09-785

# Assessment of Embrittlement of VHTR Structural Alloys in Impure Helium Environments

University of Wisconsin, Madison

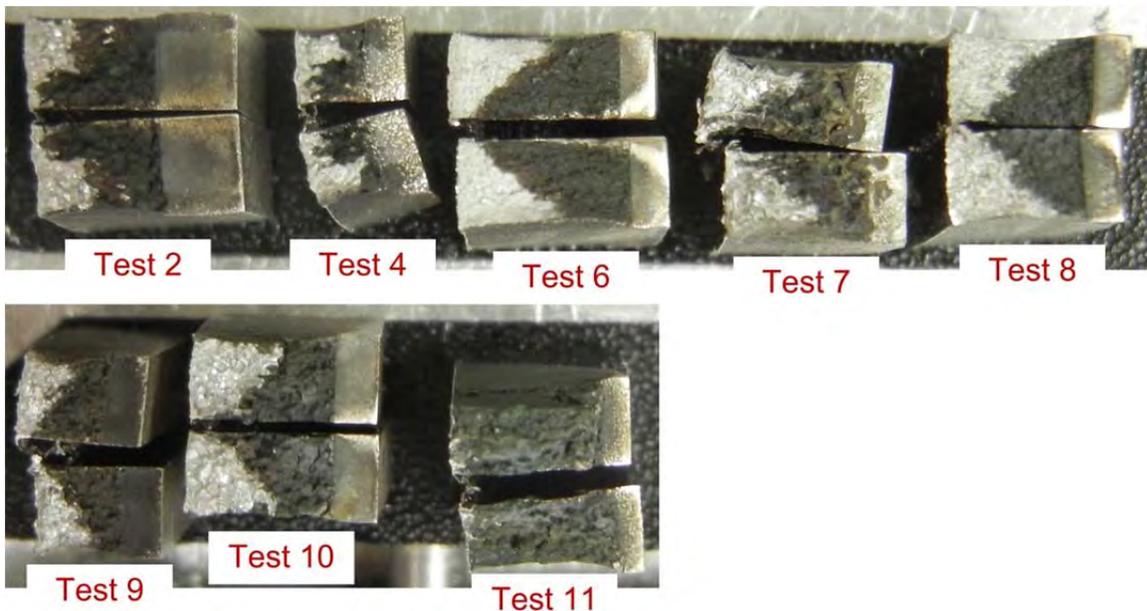
Figure 28 presents an optical image of all the fracture surfaces. The black areas are regions through which the crack propagated, and the bright areas are a result of pulling the samples apart at room temperature after the CCG testing. The right side of each fracture surface is the region that was machined via EDM prior to CCG testing. It can be readily seen that the crack is longest in the center of the sample in all cases.

**Figure 28 Optical image all fracture surfaces of a representative CCG sample from each test. The black areas of the fracture surfaces are the regions through which the crack propagated.**

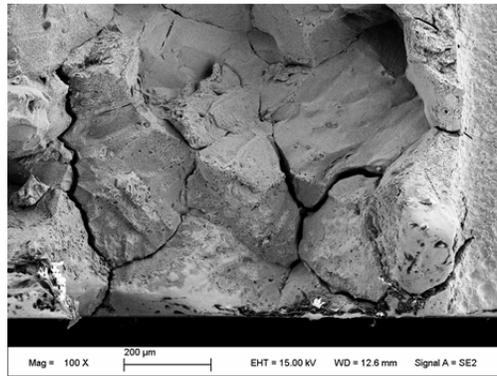
**Figure 29 SEM image of the fracture surface of Alloy 617 tested at 700 °C in air (Test 2). Large grain size, and intergranular cracking is observed.**

Figure 29 and Figure 30 present the fracture surfaces of Alloy 617 tested at 700 °C in air and helium, respectively. All cracks are intergranular. The sample tested in air shows more severe cracking compared to the sample tested in He.

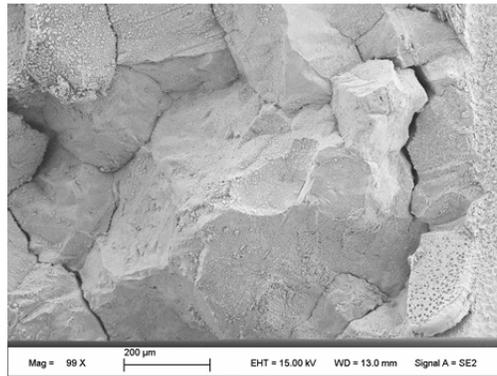
**Figure 30 SEM image of the fracture surface of Alloy 617 tested at 700 °C in helium (Test 10).**

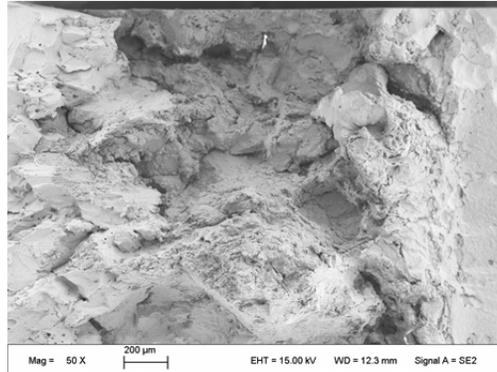
**Figure 31 SEM image of the fracture surface of Alloy 617 tested at 850 °C in air (Test 4). Severe oxidation is apparent.**

Figure 31 and Figure 32 present the fracture surfaces of Alloy 617 tested at 850 °C in air and helium, respectively. Severe oxidation is seen on the fracture surfaces; therefore, the cracking mode (intergranular or transgranular) is difficult to determine.

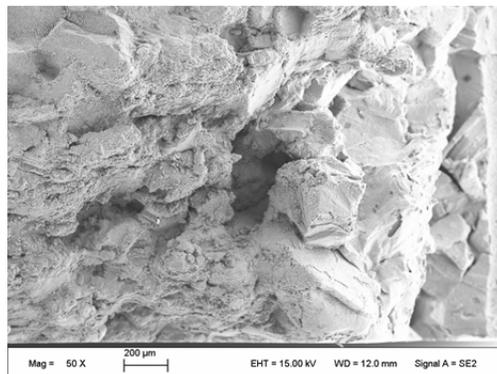
**Figure 32 SEM image of the fracture surface of Alloy 617 tested at 850 °C in helium (Test 11). Large grains and severe oxidation are observed.**

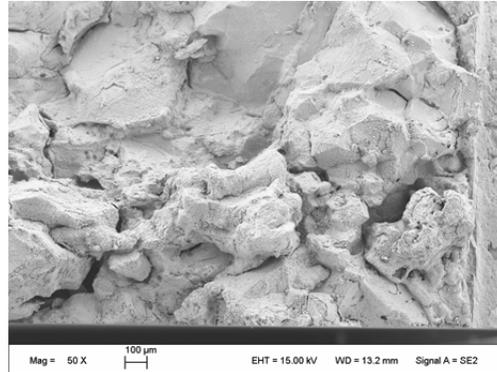
**Figure 33 SEM image of the fracture surface of Alloy 800H tested at 700 °C in air (Test 7). Large grain size, and intergranular cracking is observed.**

Figure 33 and Figure 34 show the fracture surfaces of Alloy 800H tested at 700 °C in air and in helium, respectively. Severe oxidation occurred in both testing conditions.

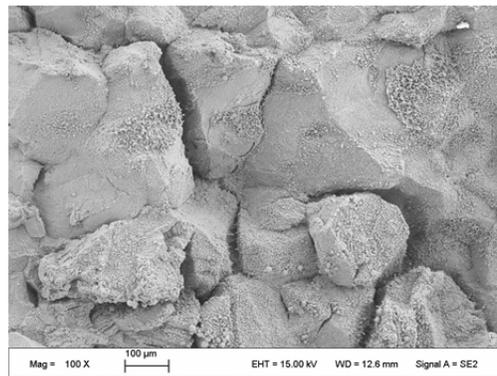
**Figure 34 SEM image of the fracture surface of Alloy 800H tested at 700 °C in helium (Test 9).**

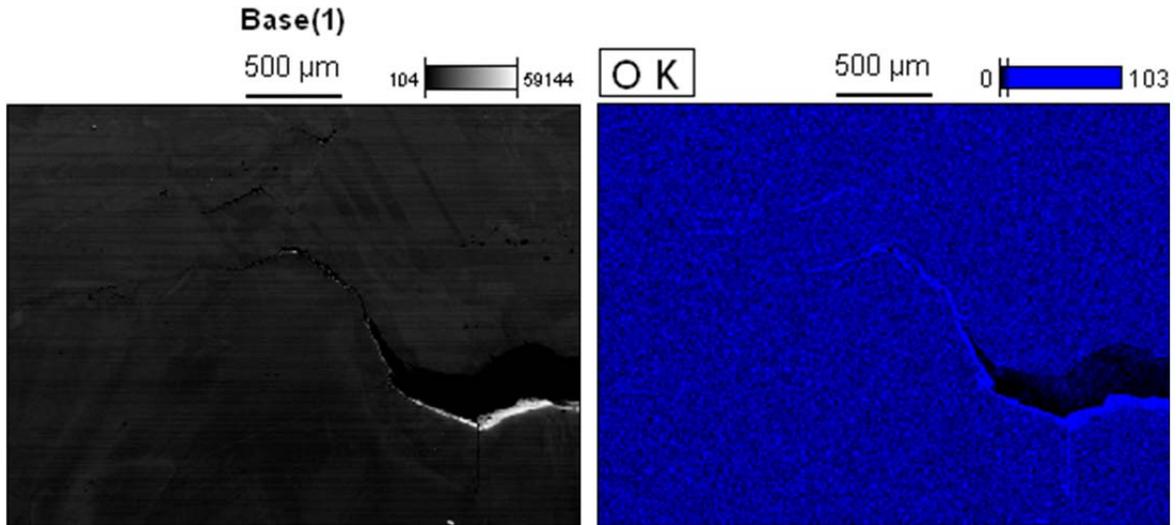
Figure 35 Crack tip oxidation in Alloy 617 tested at 700°C in air (Test 2).

Figure 35 presents the crack tip oxidation in Alloy 617 tested at 700 °C in air. Figure 36 presents the EDS mapping of a crack tip in Alloy 617 tested at 850 °C in air. Oxidation in the crack tip and also along the grain boundaries near the crack tip is observed. The oxygen signal is weak, therefore observing oxidation near the boundaries is difficult in general.

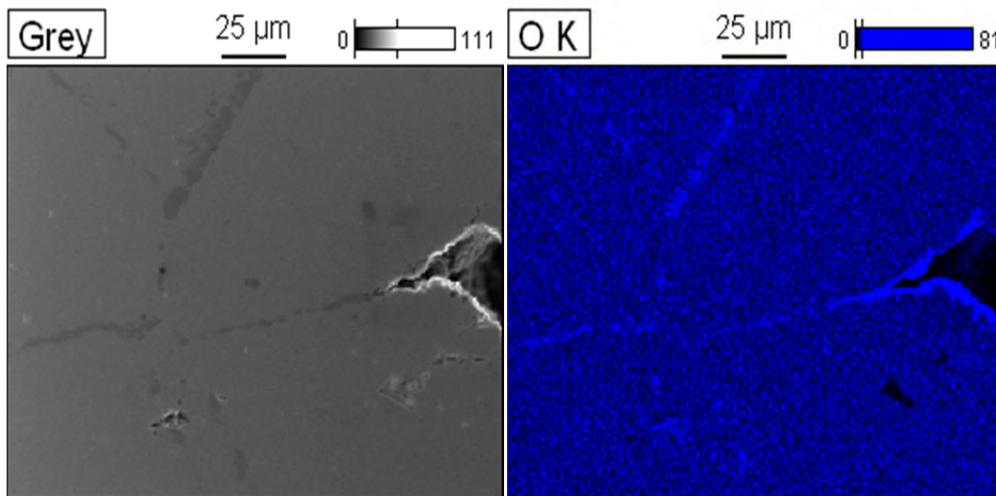
Figure 36 Crack tip oxidation and grain boundary oxidation in Alloy 617 test at 850 °C in air (Test 4).

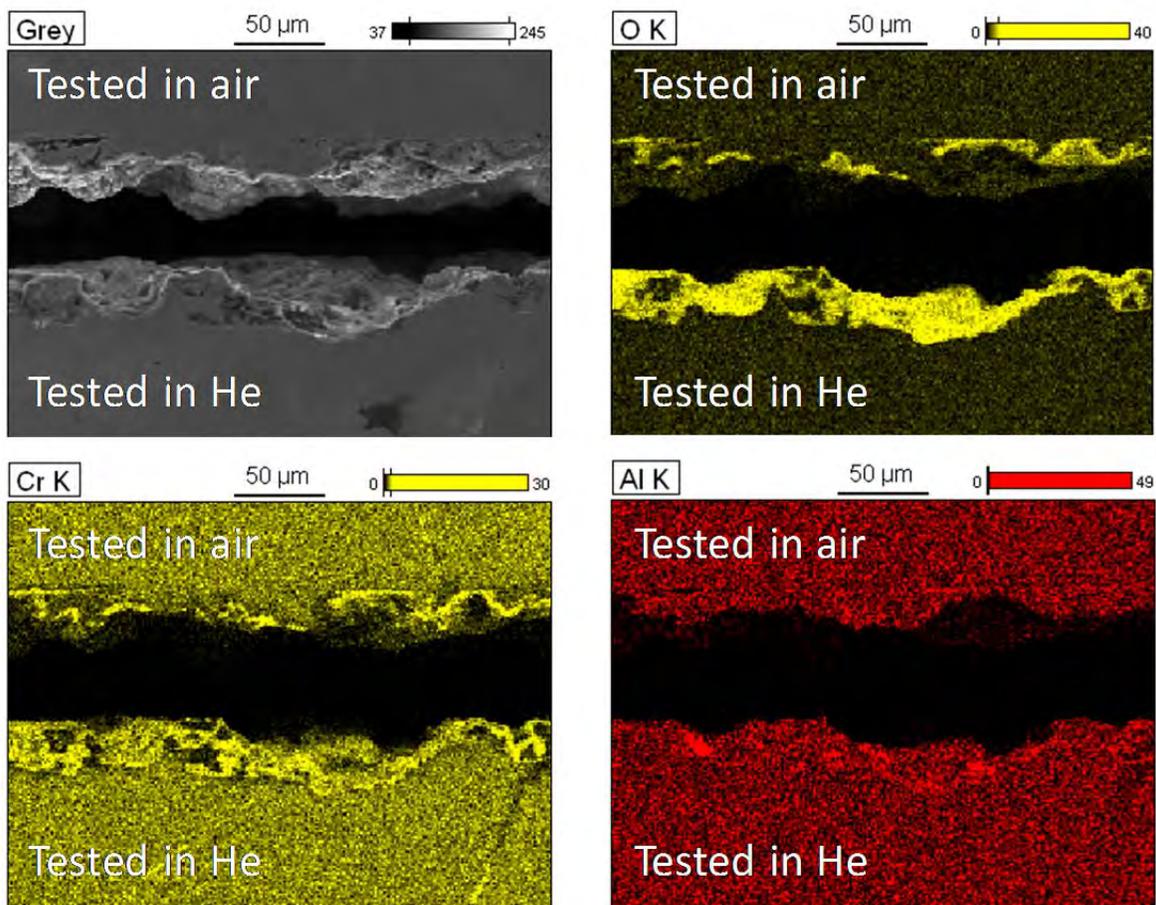
**Figure 37 EDS mapping of Alloy 617 tested at 700 °C in air (top half of image) and helium (bottom half of image). An aluminum-rich phase is present in Alloy 617 tested in helium.**

Figure 37 presents the oxidation of Alloy 617 tested at 700 °C in air and in helium . In each image, the sample on the top is the one tested in air, and the sample on the bottom is the one tested in He. The oxidation of Alloy 617 tested in both conditions is similar, with the oxide consisting mainly of chromium oxide, although there is the presence of an aluminum-rich phase in Alloy 617 tested in He.

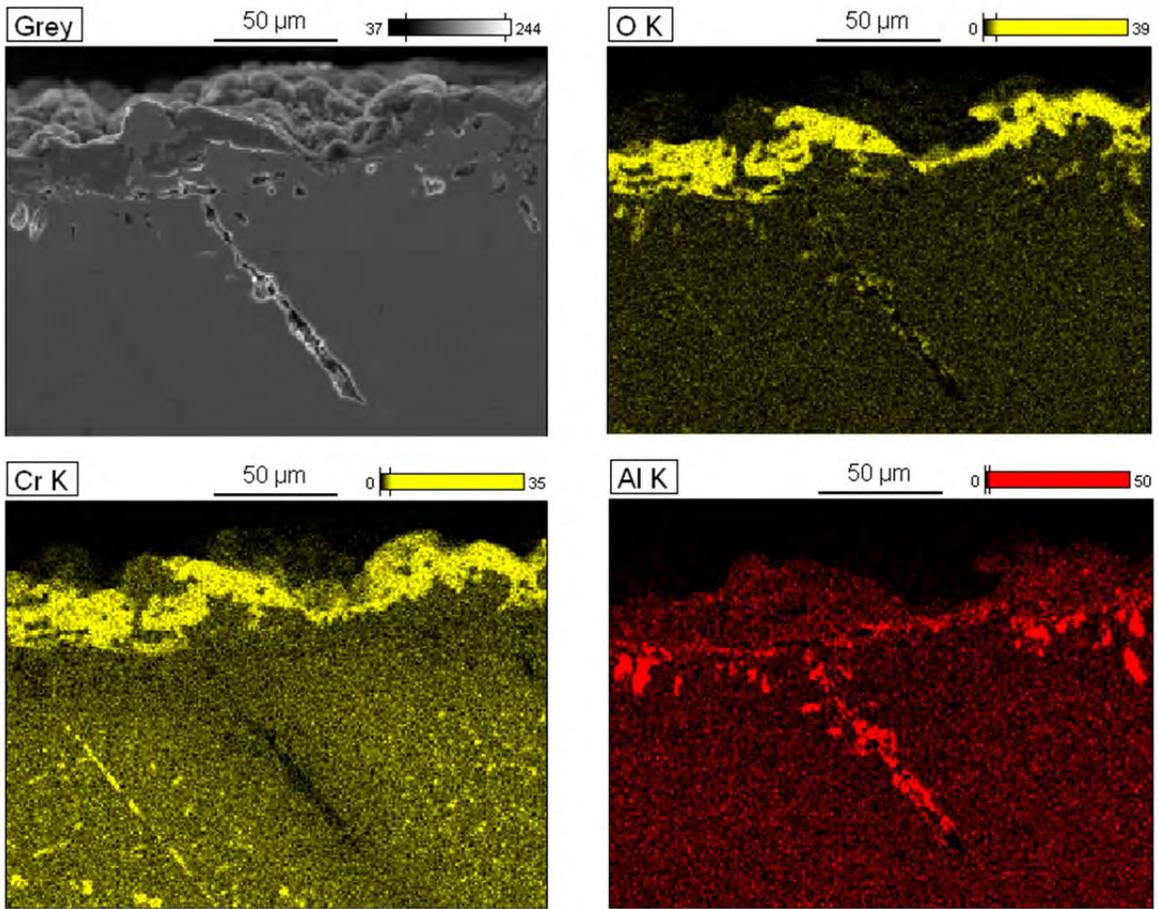
**Figure 38 EDS mapping of Alloy 617 tested at 850 °C in air. A significant amount of aluminum-rich phases are observed on the surface and along some of the grain boundaries.**

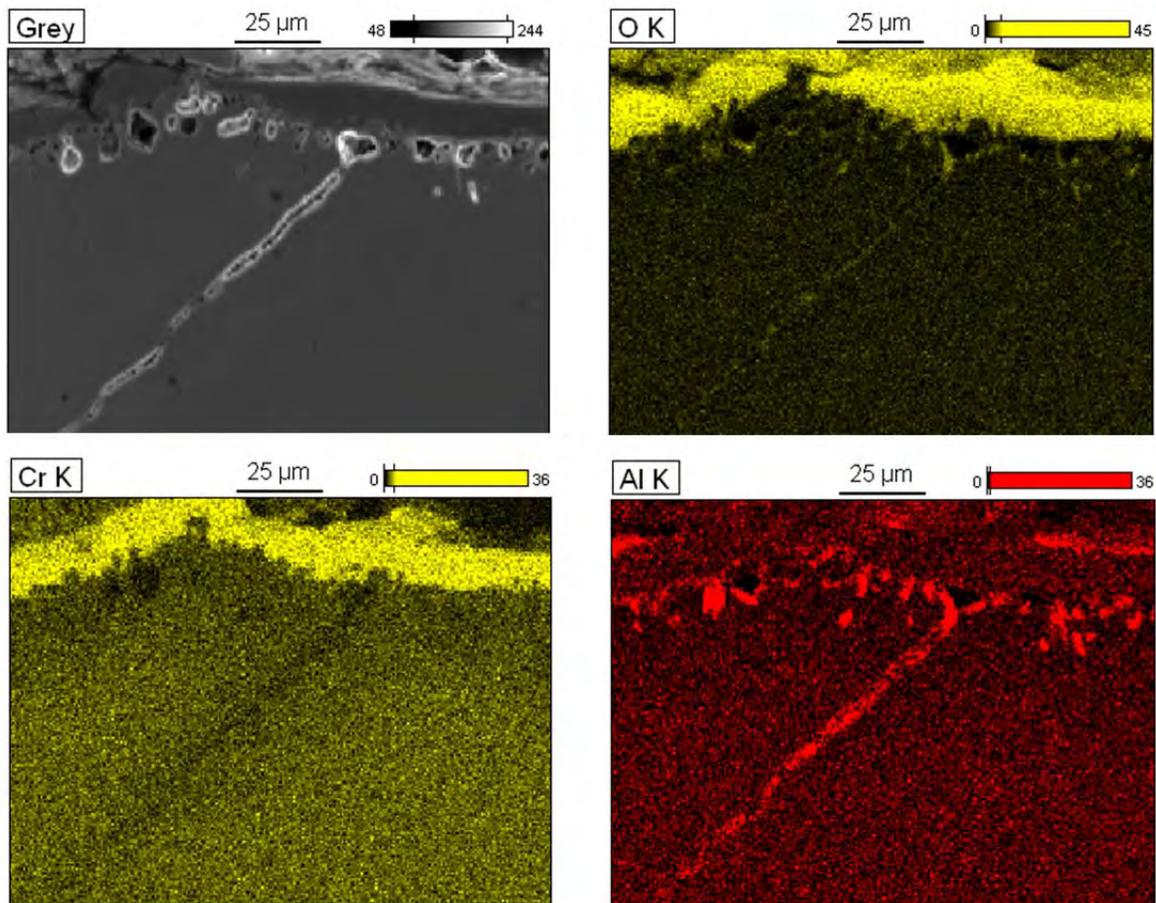
**Figure 39 EDS mapping of Alloy 617 tested at 850 °C in helium. A significant amount of aluminum-rich phases are observed on surface and along some of the grain boundaries.**

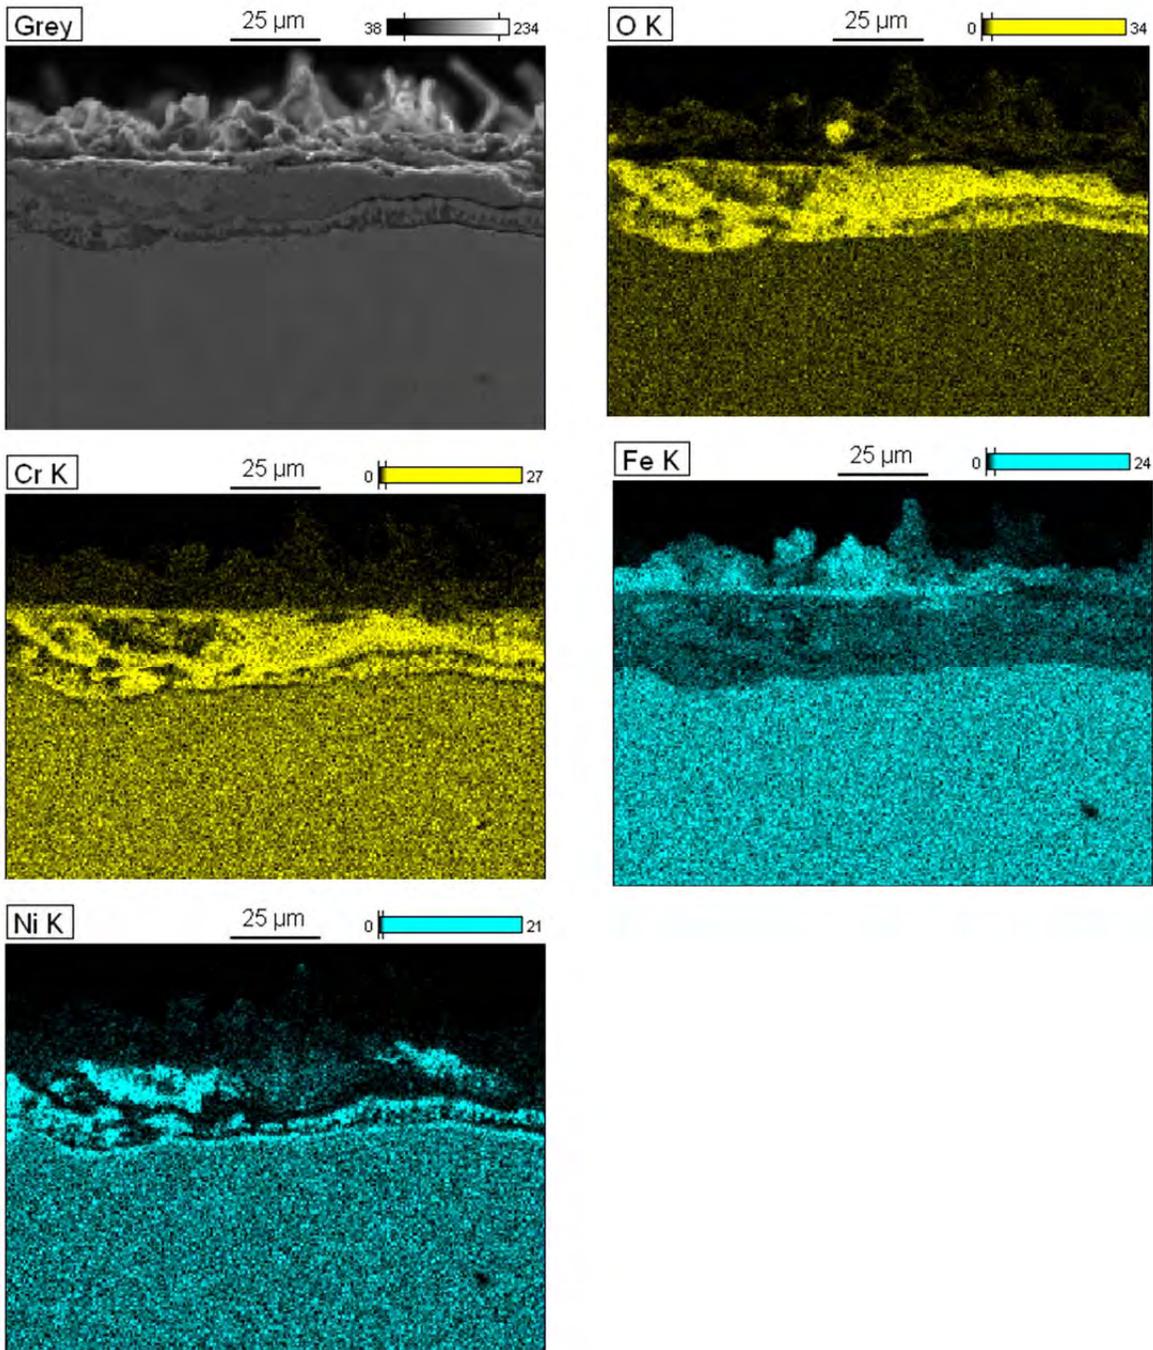
**Figure 40 EDS mapping of Alloy 800 tested at 700 °C in air (Test 7). The outer layer is an iron oxide, and the inner layer is a chromium oxide.**

From the SEM images and EDS analyses of the oxidation of the materials tested at 700 °C in air and helium, Alloy 617 appears to have similar oxidation behavior in both environments, with a very thin oxidation layer forming on the surfaces of the alloy. This may explain the similarity in the creep crack growth rates of Alloy 617 tested in air and in impure helium. When Alloy 617 is tested at 850 °C, the degree of oxidation on the surface is more severe, and again the oxidation in the air and helium environments is similar. In both environments, there is significant formation of aluminum oxide phases along the inner oxidation layer and along a number of grain boundaries. Alloy 800H shows some slight differences in oxidation in air compared with helium. When Alloy 800H was tested in air, the outer layer is iron oxide and the inner layer is chromium oxide. But when tested in helium, the oxidation layer is mainly composed of chromium oxide.

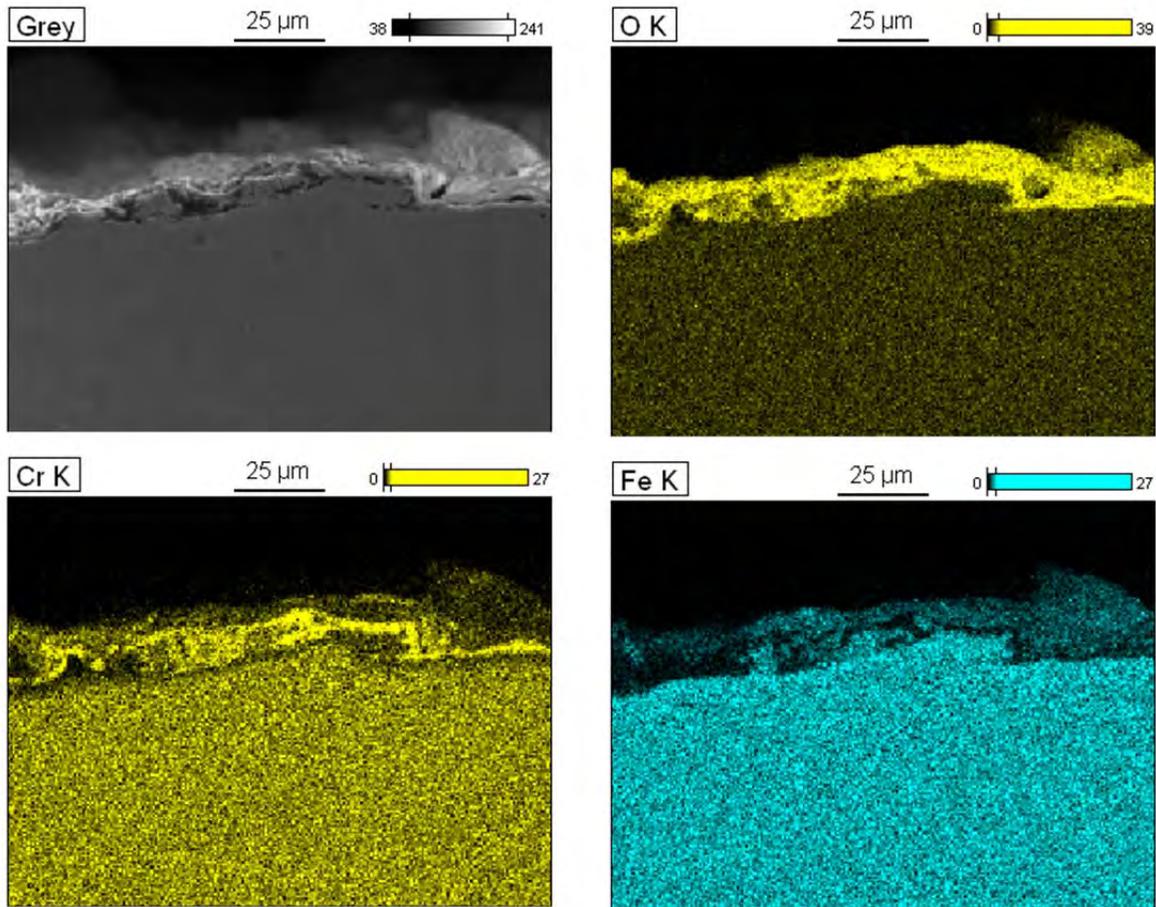
**Figure 41 EDS mapping of Alloy 800H tested at 700 °C in helium (Test 9). The oxide is mainly a chromium oxide.**

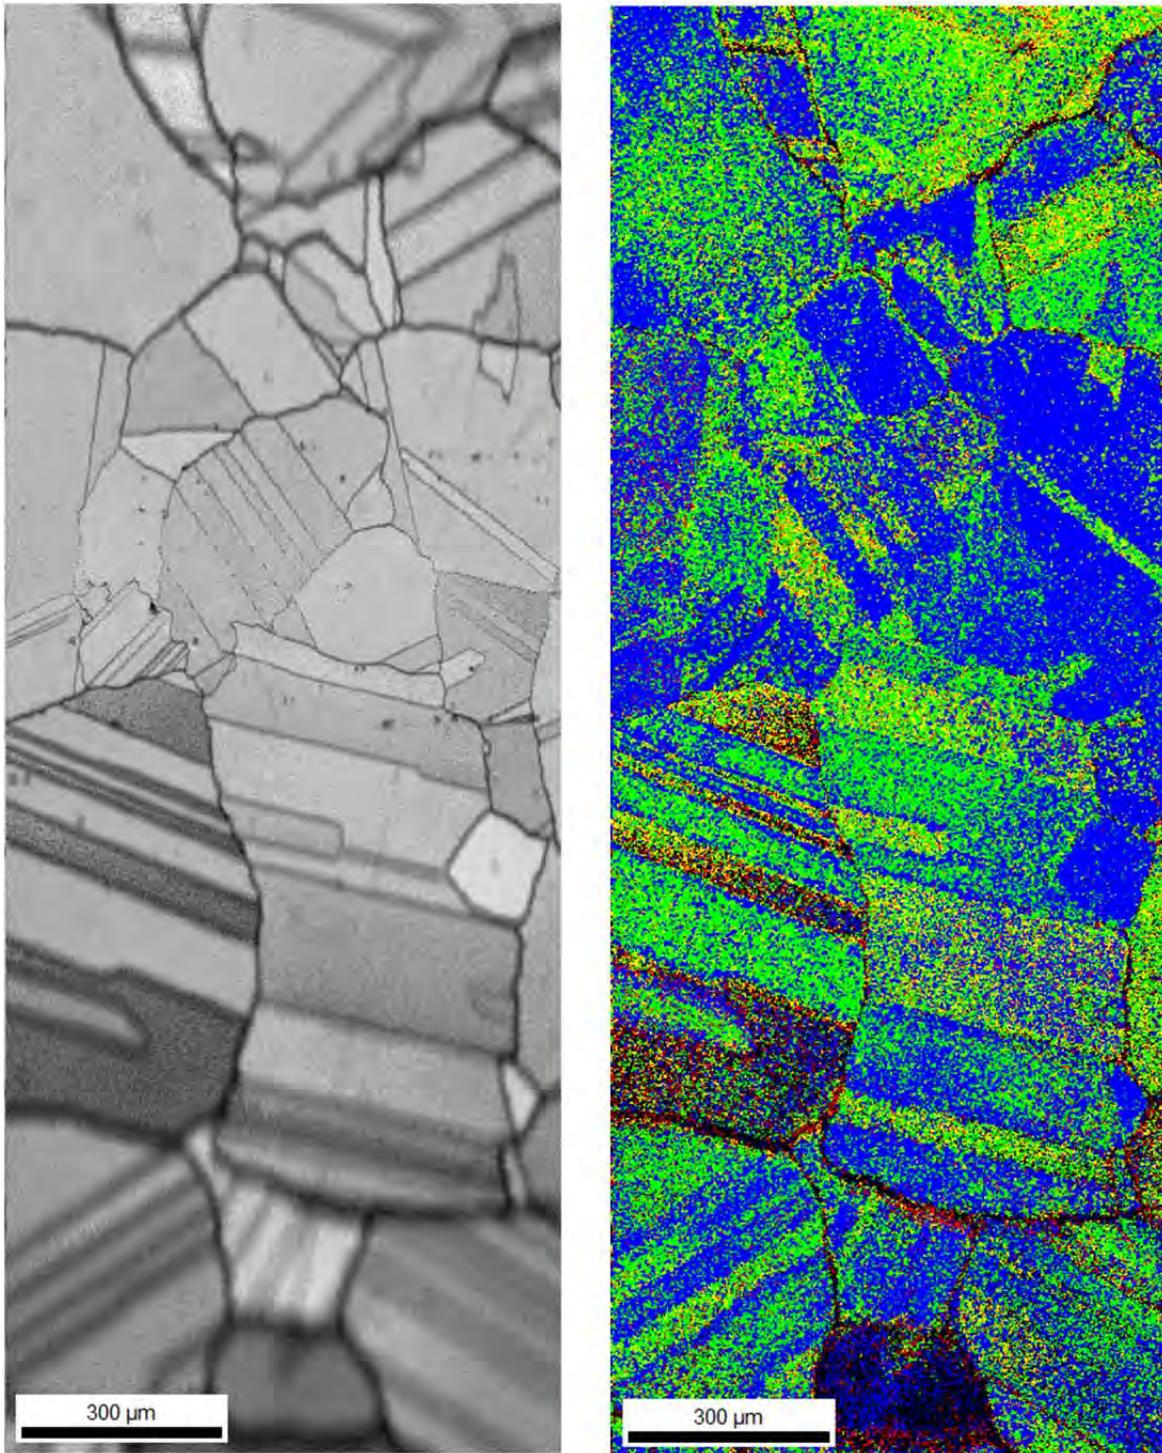
**Figure 42 EBSD mapping of an Alloy 617 sample after solution treatment and aging, but prior to CCG testing.**

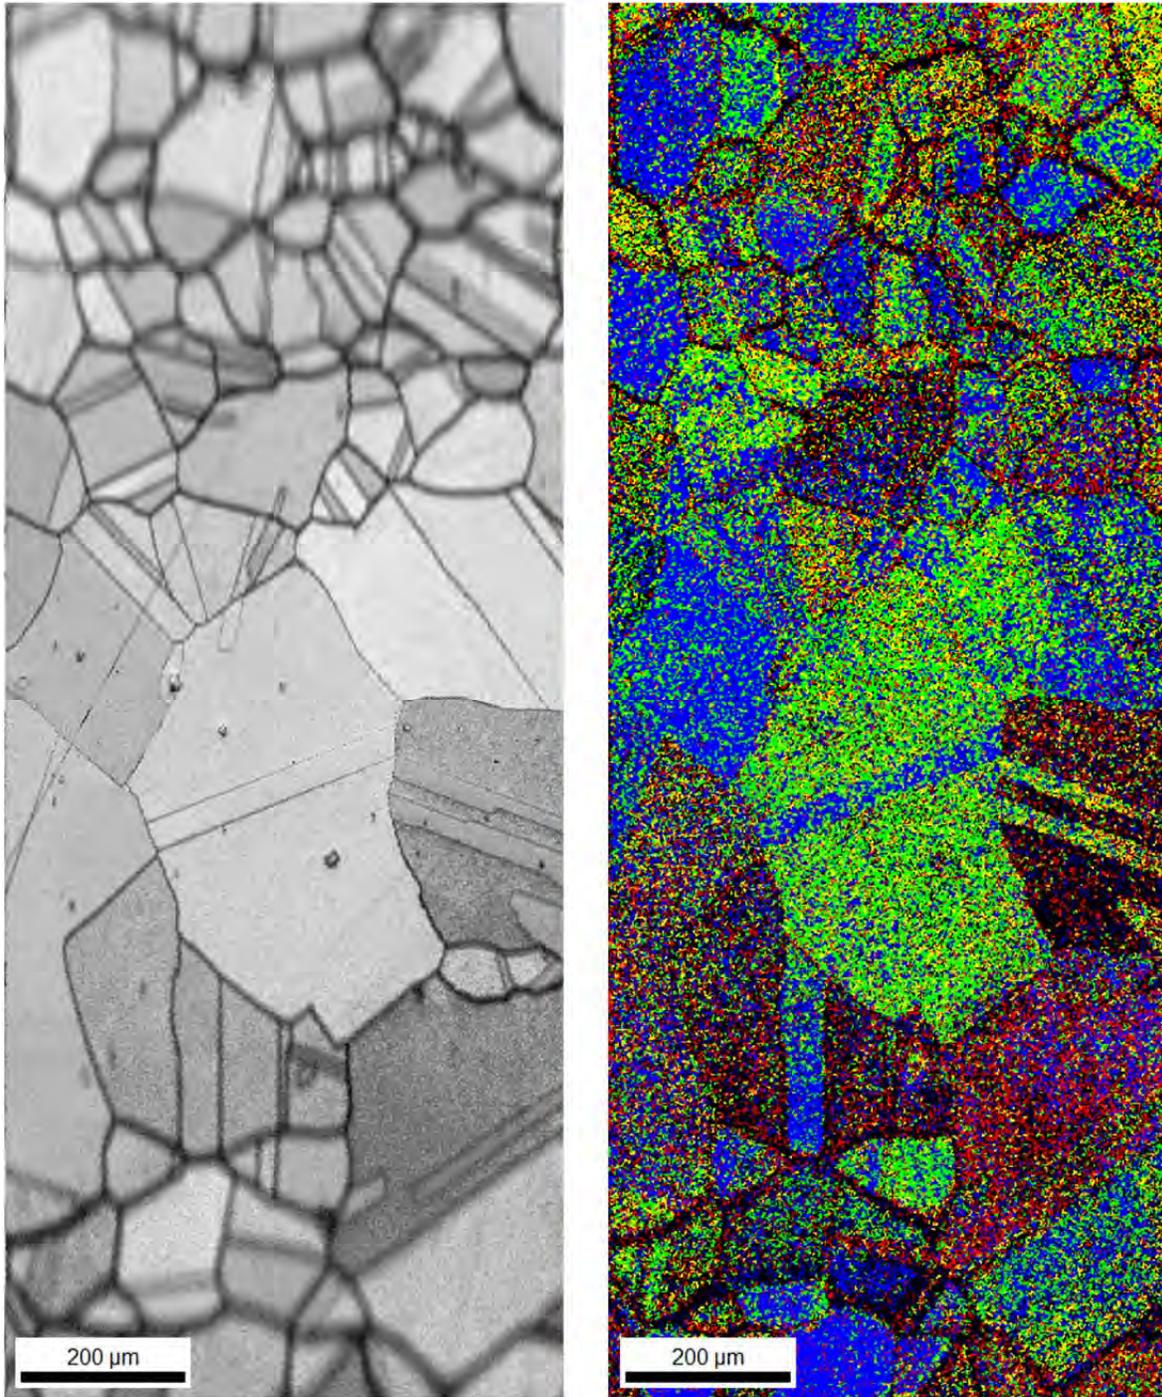
**Figure 43 EBSD mapping of an Alloy 800H sample after solution treatment and aging, but prior to CCG testing.**

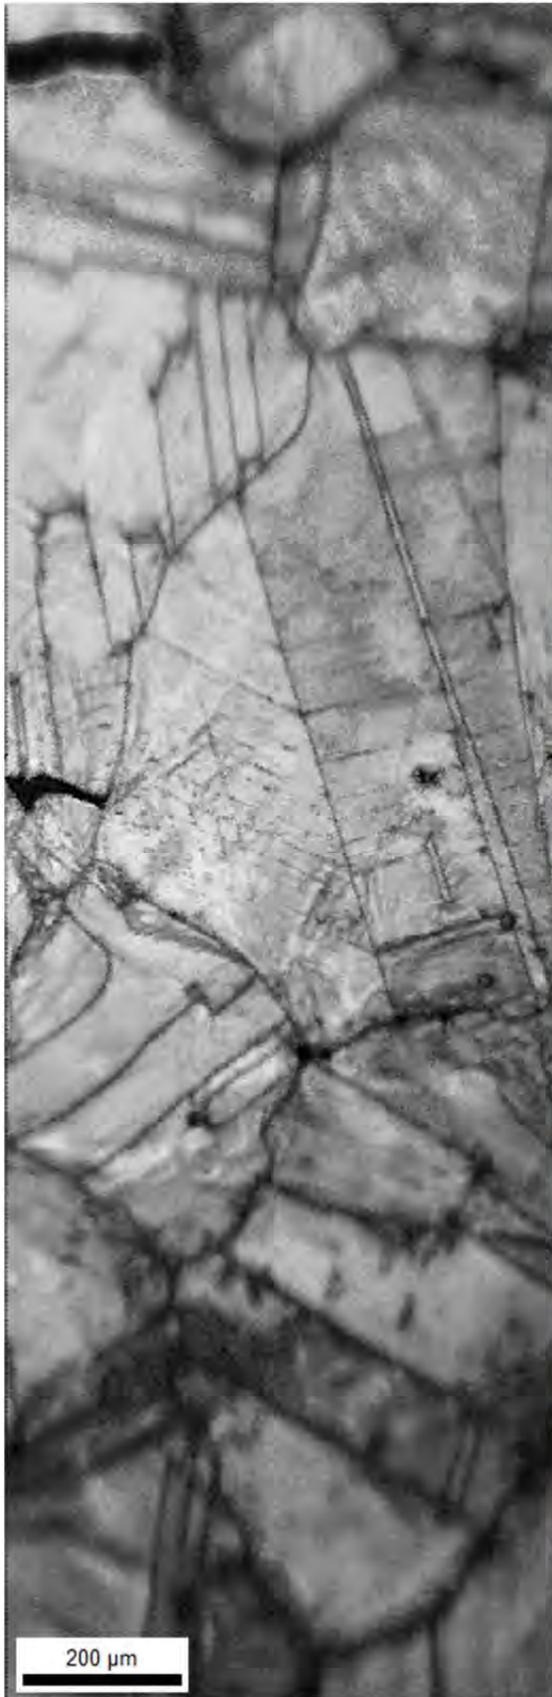
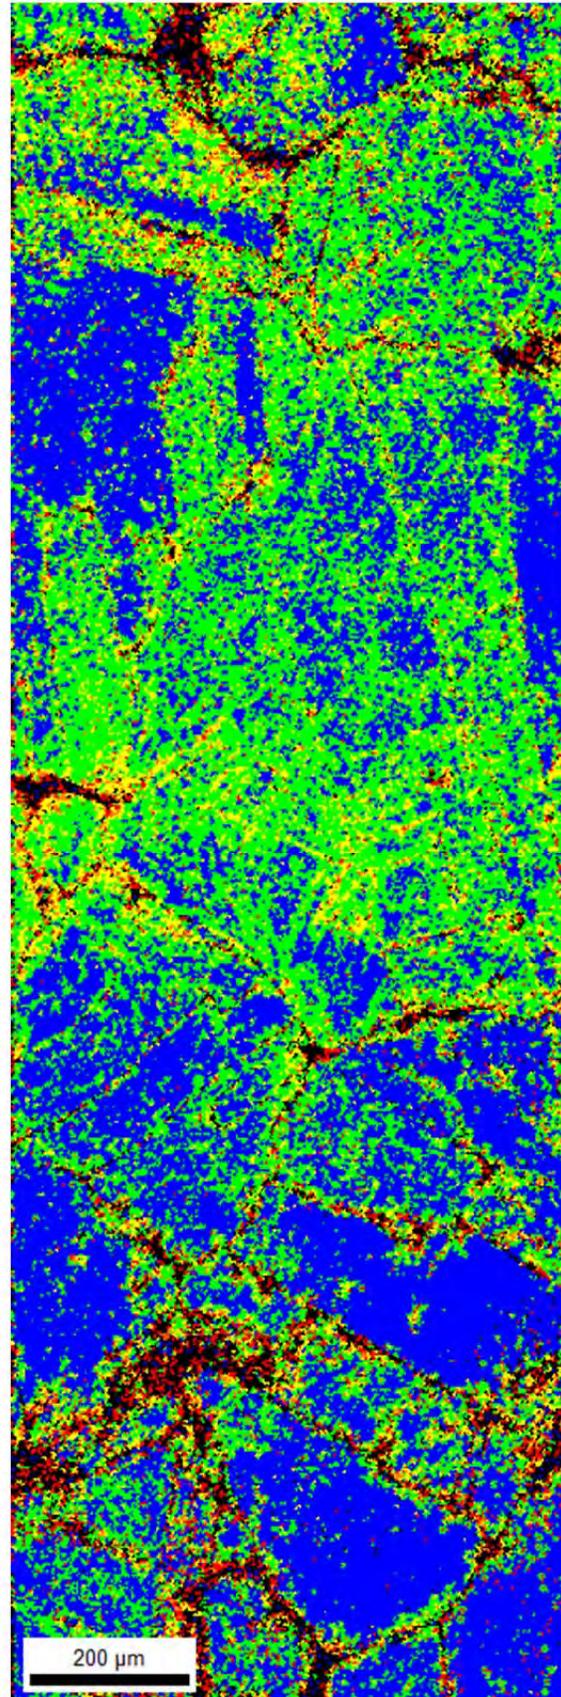
**Figure 44 EBSD mapping of the crack tip and crack cavitations in Alloy 617 tested at 700 °C in air (Test 2).**

Significant strain is observed in the regions near the crack tips (Figure 44 and Figure 46). In general, the cracks appear to have initiated in the grain boundaries with a higher degree of misorientation and strain (Figure 47 and Figure 59).

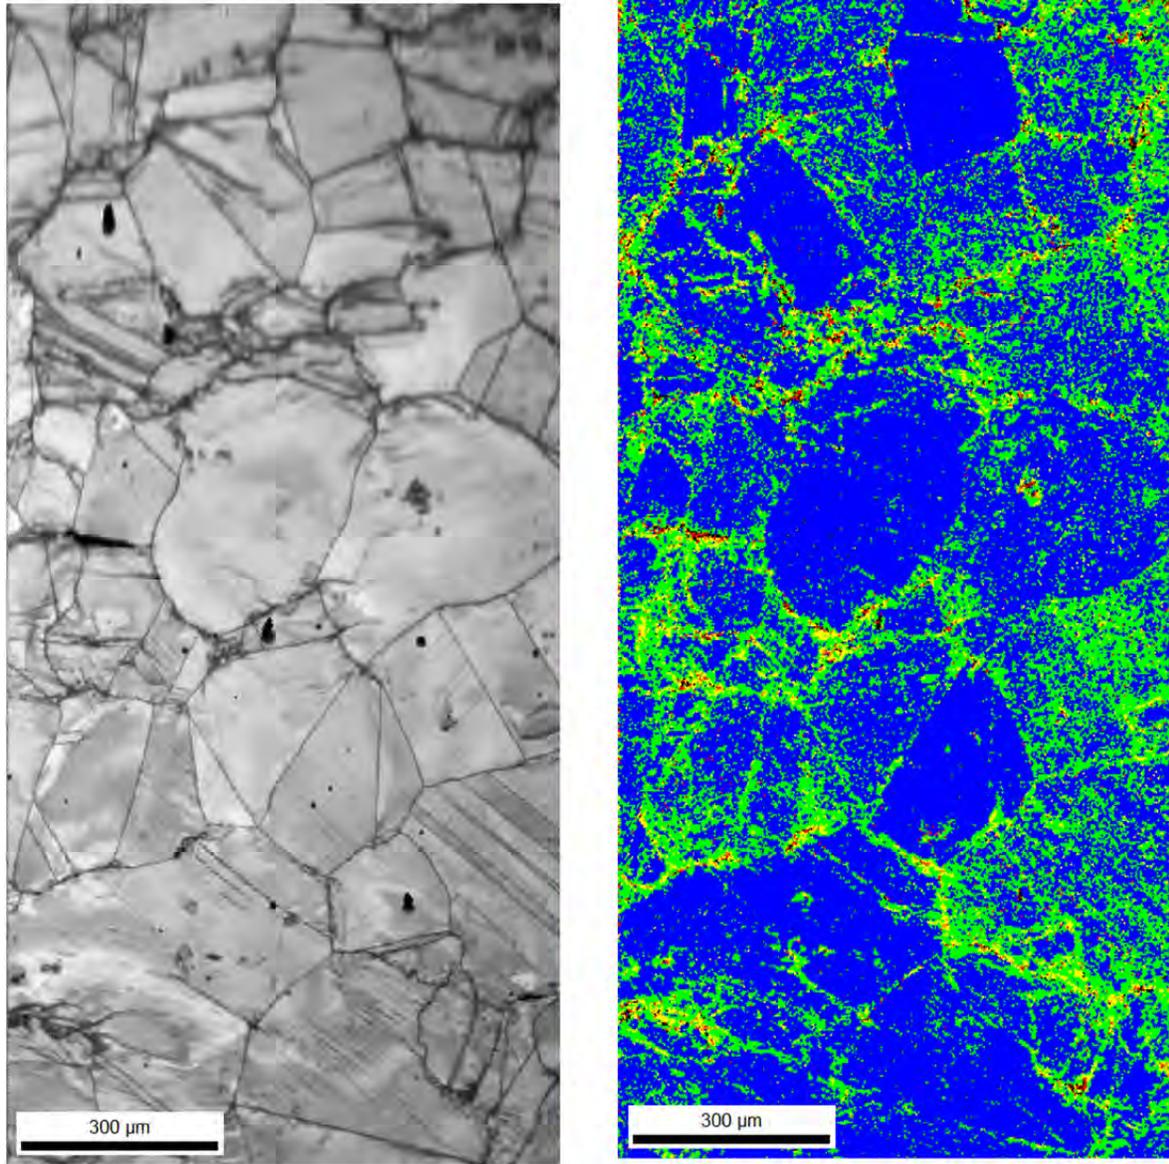
**Figure 45 EBSD mapping of a crack cavitation in Alloy 617 tested at 700 °C in helium (Test 10).**

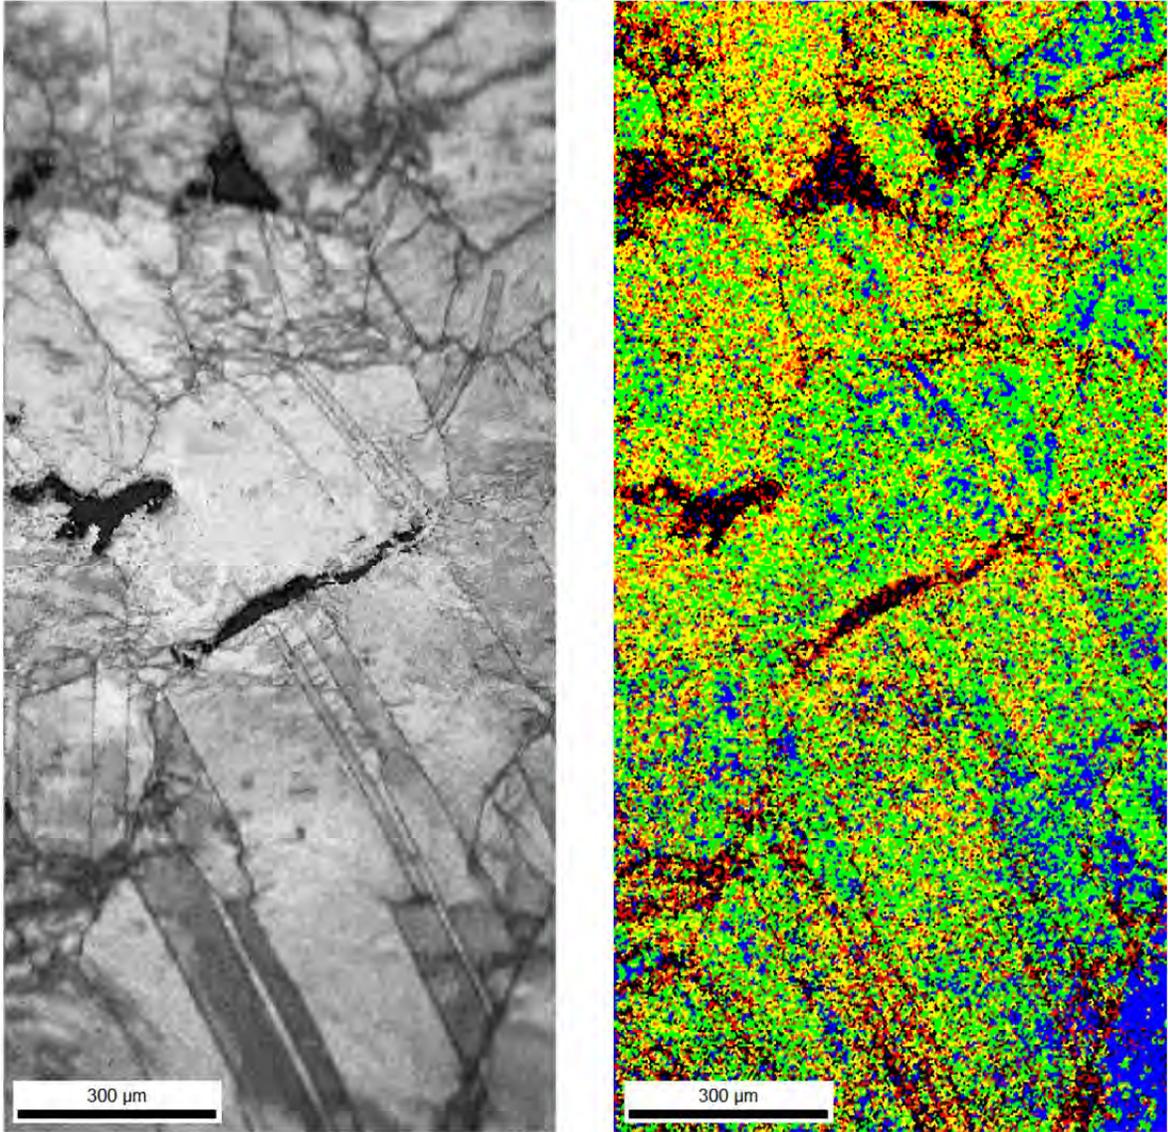
Figure 46 EBSD mapping of crack cavitations in Alloy 617 tested at 850 °C in air (Test 4).

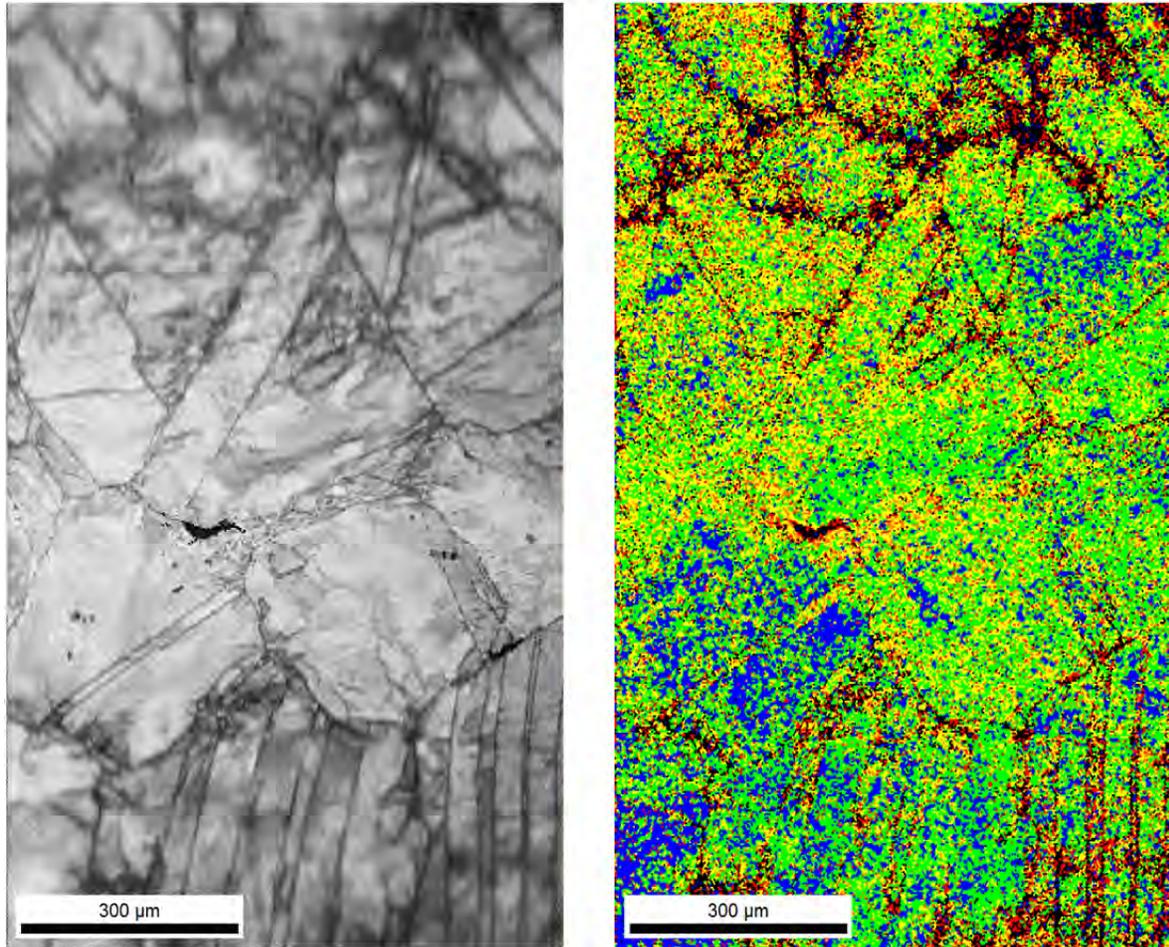
**Figure 47 EBSD mapping of crack cavitations in Alloy 617 tested at 850 °C in air (Test 4).**

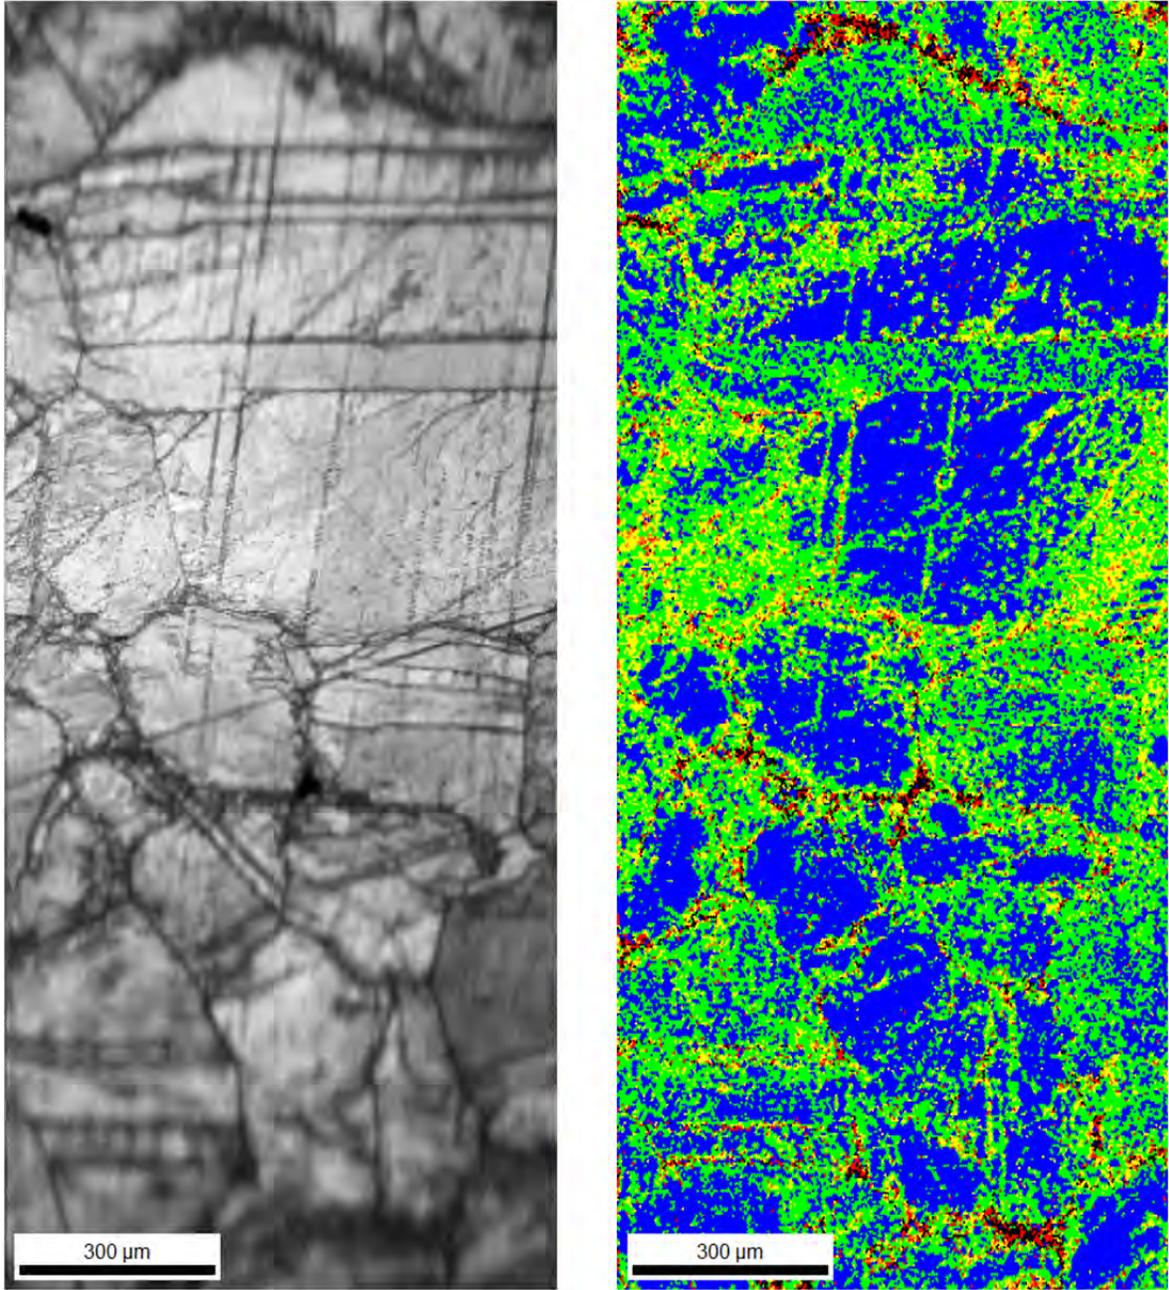
**Figure 48 EBSD mapping of a crack cavitation in Alloy 617 tested at 850 °C in helium.**

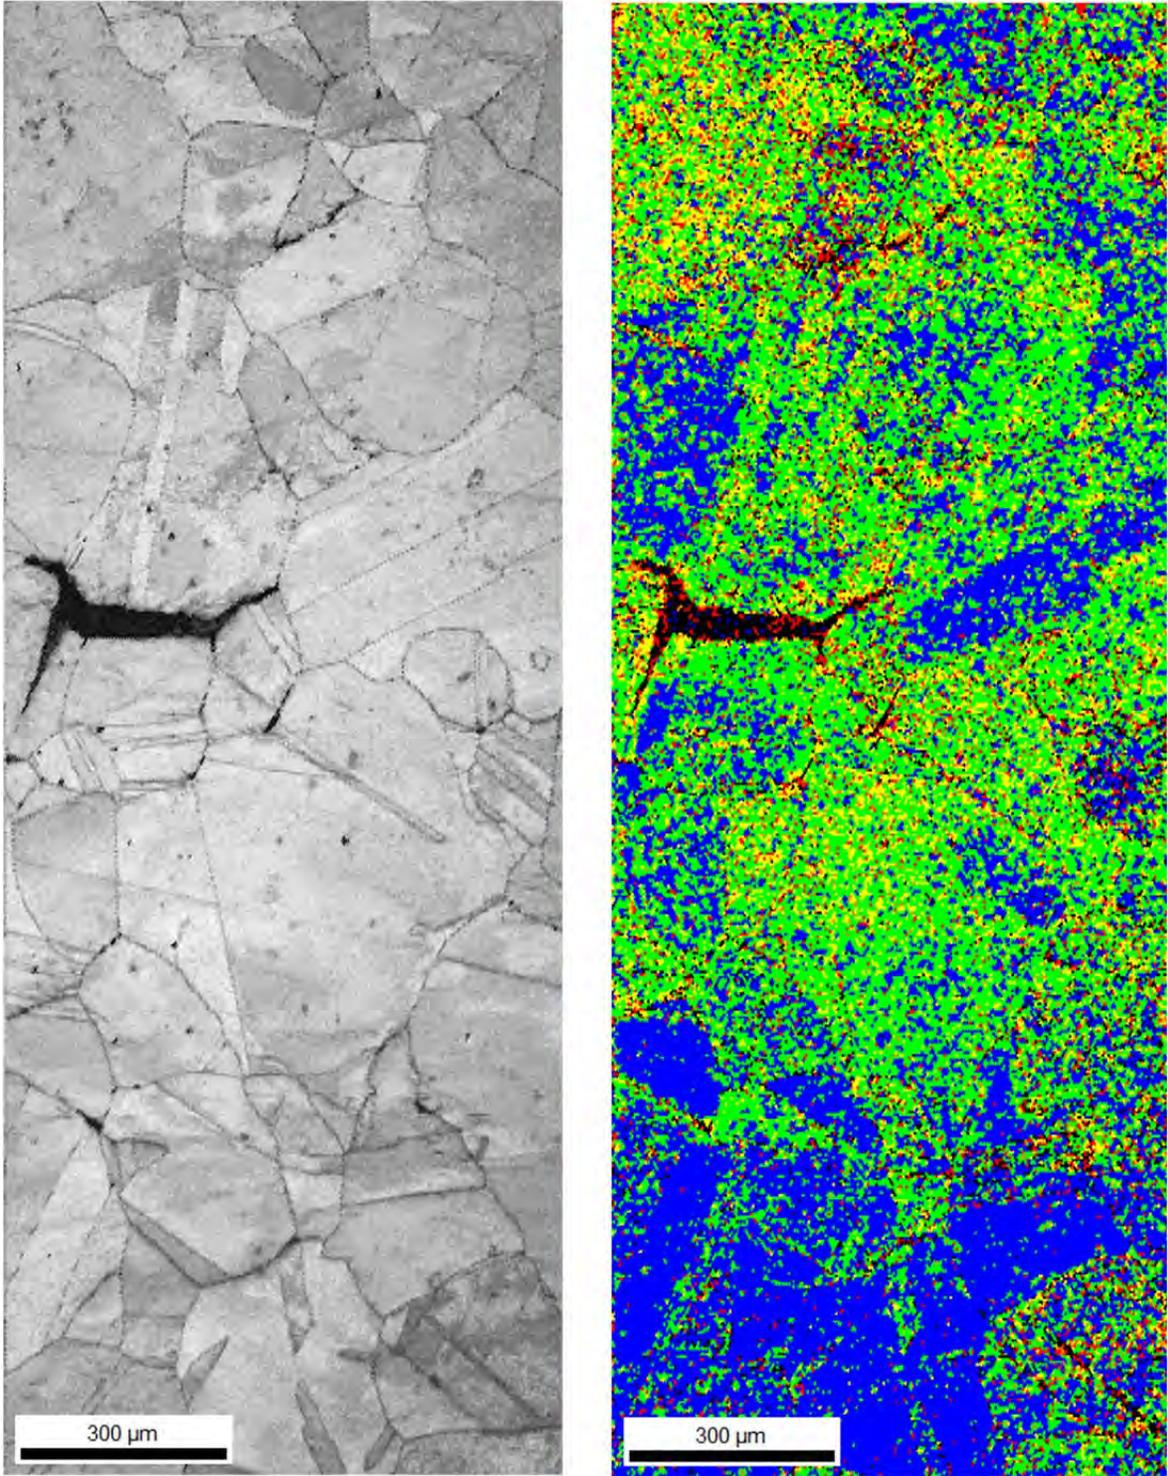
Figure 49 EBSD mapping of a crack tip in Alloy 800H tested at 700 °C in air (Test 7).
