Project No. 09-785

# Assessment of Embrittlement of VHTR Structural Alloys in Impure Helium Environments

University of Wisconsin, Madison

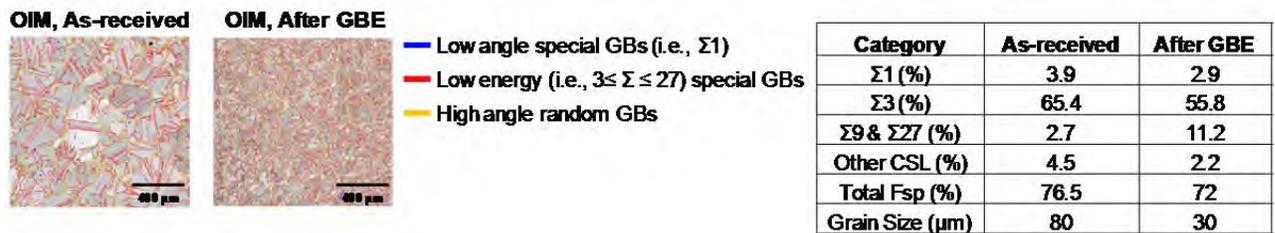
Figure 50 GBE results from Alloy 617 samples. (Left) Orientation Imaging Microscopy (OIM) images from the 617 alloy before and after GBE. (Right) Microstructural characteristics for the as-received and the GBE-optimized samples.

The GBE processing protocols developed Integran Technologies were successful in improving the microstructural characteristics of Alloy 617. The following description of the GBE results are paraphrased from a report provided by Integran. The improvement of the microstructural characteristics was achieved through modification of processing parameters to facilitate multiple twinning leading to an elevated frequency of special grain boundary content and enhanced special grain boundary connectivity at local triple junctions. Figure 50 presents the essential results for the as-received and GBE-optimized Alloy 617 samples. Compared to the material in the as-received condition, the microstructural characteristics of the GBE-optimized samples can be summarized as follows: (1) a grain size of  $\sim 30\mu\text{m}$ , (2) an enhanced ‘special’ (i.e.,  $\Sigma \leq 29$ ) grain boundary frequency in the range of  $\sim 70\%$  with a significant increase in the presence of twin variant interfaces (i.e.,  $\Sigma 9$  and  $\Sigma 27$ ), and (3) an improved grain boundary network connectivity which is evidenced by the increase in the frequency of triple junctions with three special grain boundaries. If the assumption that the special grain boundaries are more resistant to crack initiation and propagation is correct, the enhanced connectivity of the special grain boundaries in the GBE-optimized material, as manifested in the triple junction make-up, should yield a more tortuous intercrystalline network for intergranular penetration for corrosion and cracking.

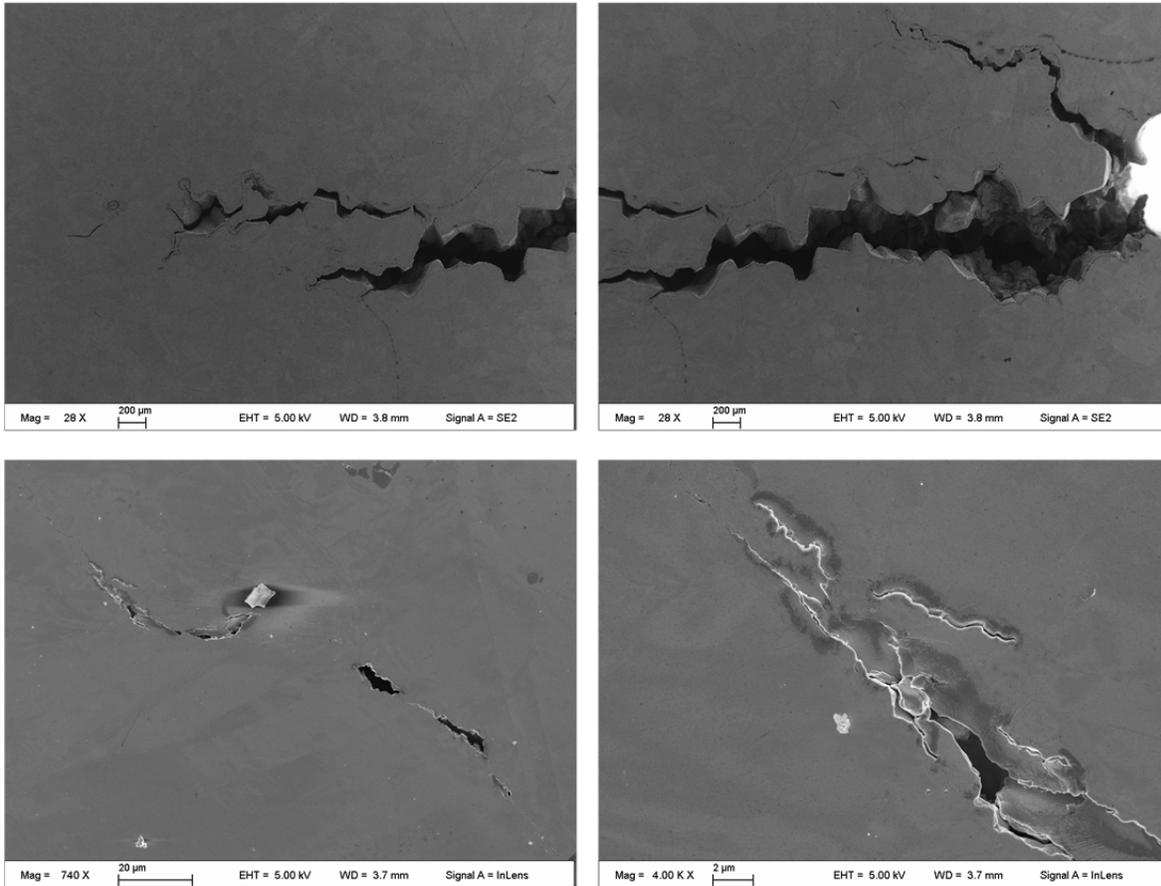
**Figure 51 Cracks and crack cavitations in the as-received Alloy 617 sample tested 700 °C in helium (Test 8). Severe cracking is observed, with many tiny cracks seen in front of the major crack tip. Oxidation of the crack cavitations can be also be seen.**

Figure 51 and Figure 52 present the crack morphologies of the GBE and as-received Alloy 617 samples, respectively, tested at 700 °C in helium. Cracks much more severe than those of the aged samples appeared in both samples.

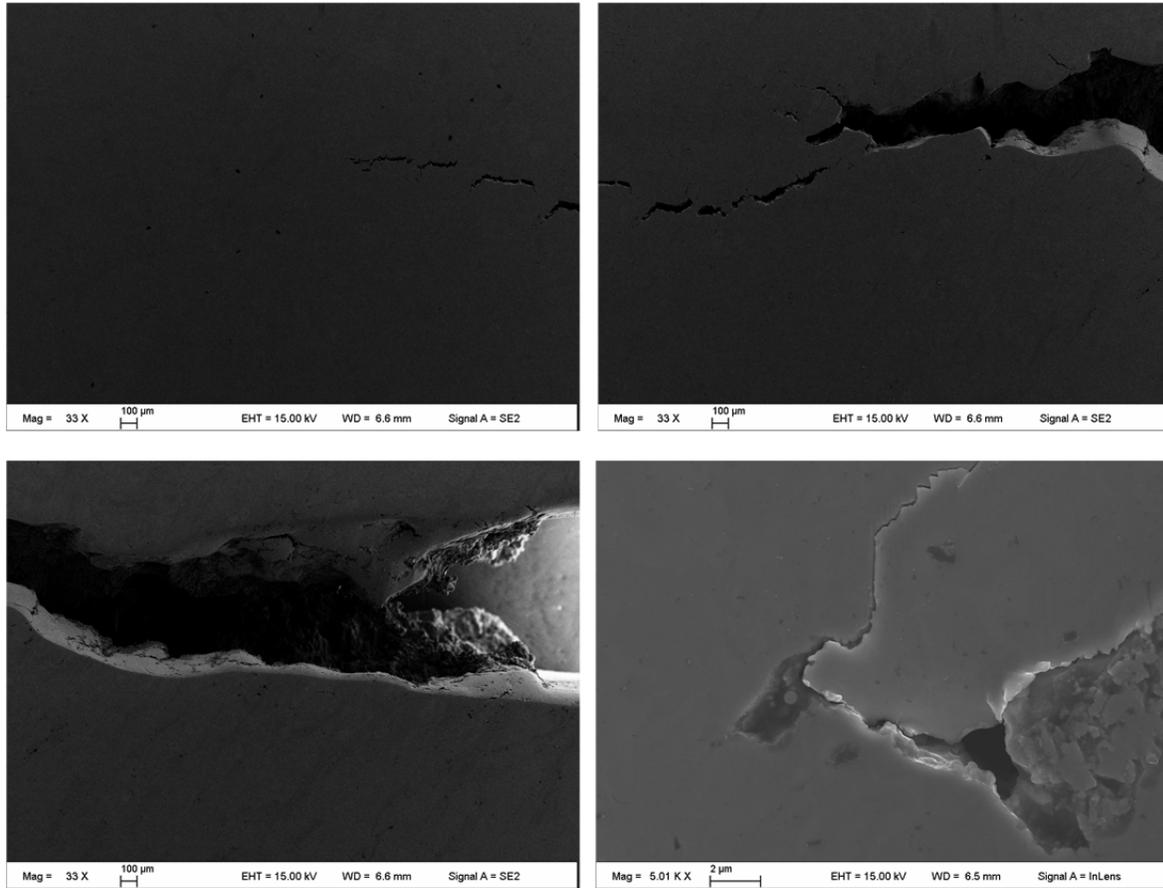
**Figure 52 Crack in the GBE Alloy 617 sample tested at 700 °C in helium (Test 6).**

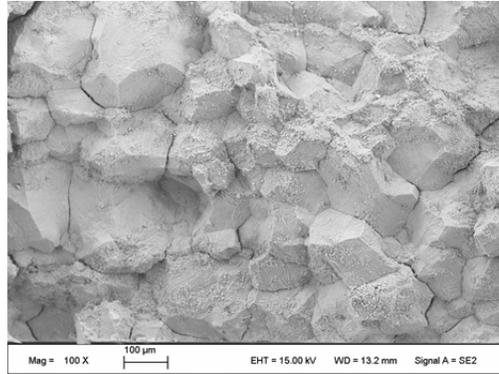
**Figure 53 SEM image of the fracture surface of as-received Alloy 617 tested at 700 °C in helium (Test 8). Small grain size, and intergranular cracking, and many small crack branches are observed.**

Figure 53 and Figure 54 show the fracture surfaces of as-received and GBE Alloy 617, respectively, tested at 700 °C in helium. As compared to the aged 617 Alloy, the grain size of the as-received and GBE is much smaller. The cracks appear to be intergranular, and many crack branches are observed in the GBE sample.

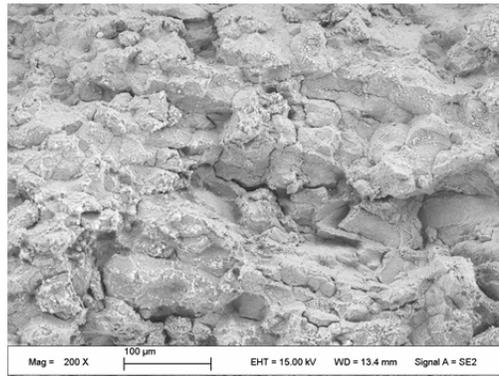
**Figure 54 SEM image of the fracture surface of GBE Alloy 617 tested at 700 °C in helium (Test 6). Small grain size, and intergranular cracking, and many crack branches are observed.**

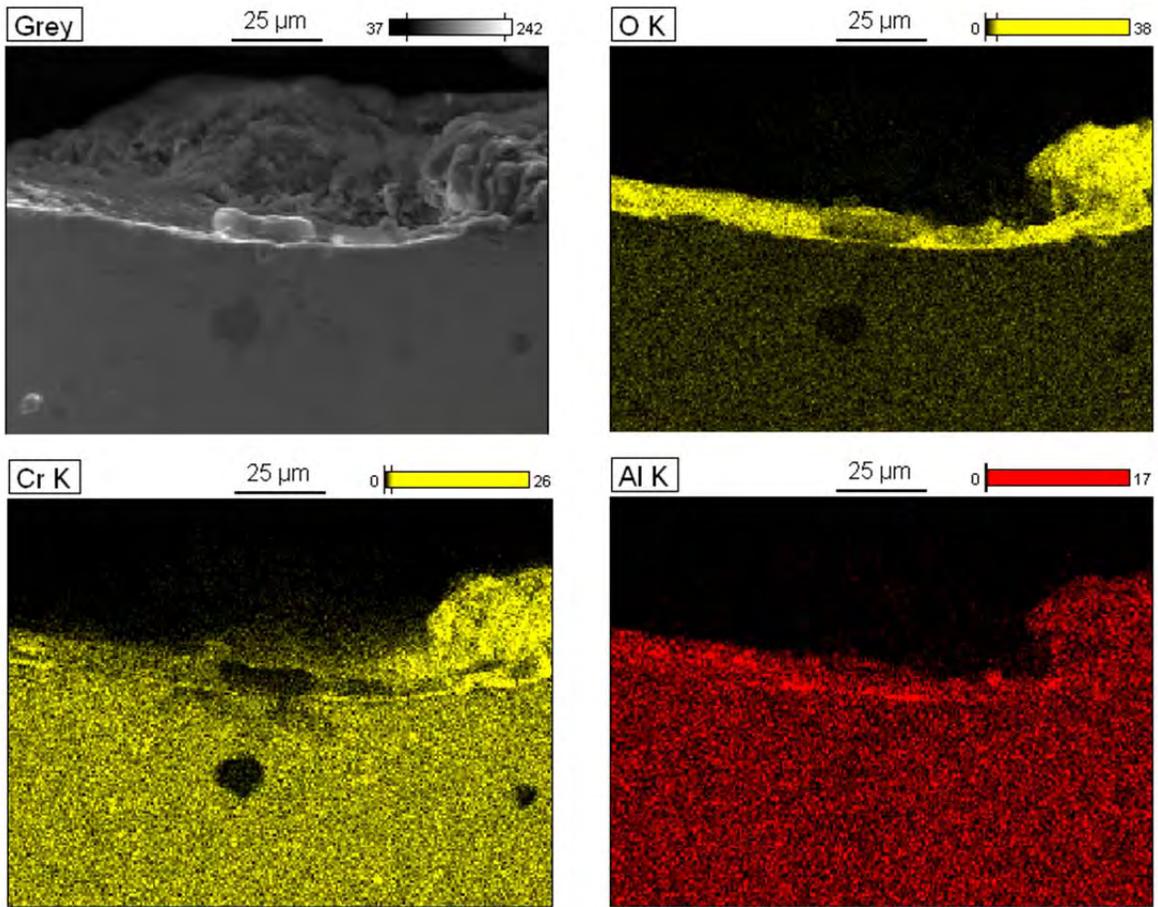
Figure 55 EDS mapping of as-received Alloy 617 tested at 700 °C in helium (Test 8).

Figure 55 and Figure 56 show the oxidation of as-received and GBE Alloy 617, respectively. A thin chromium oxide layer is observed in both samples. A slight presence of an aluminum-rich phase is observed in both the GBE and as-received samples.

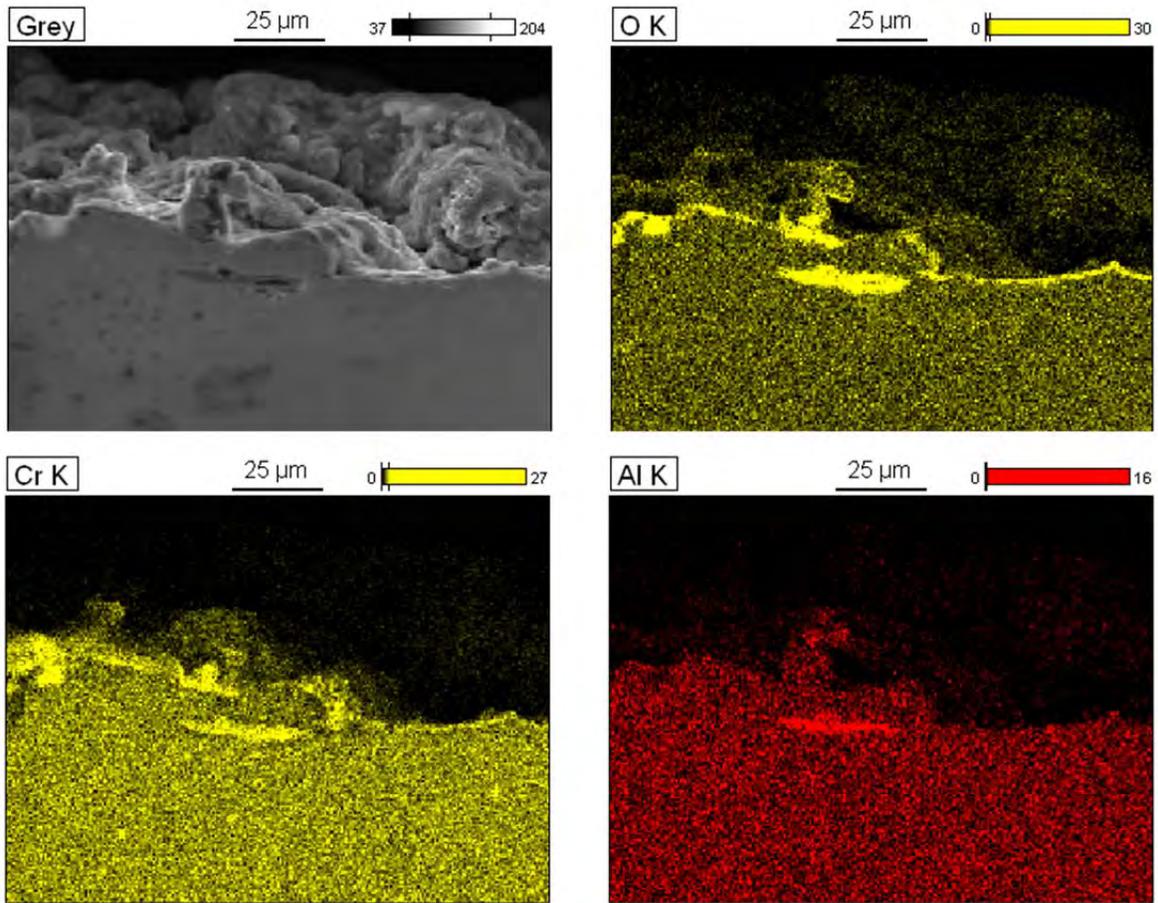
**Figure 56 EDS Mapping of GBE processed Alloy 617 tested at 700oC in helium (Test 6). Very thick chromium oxide layer. Some aluminum rich phase can be seen.**

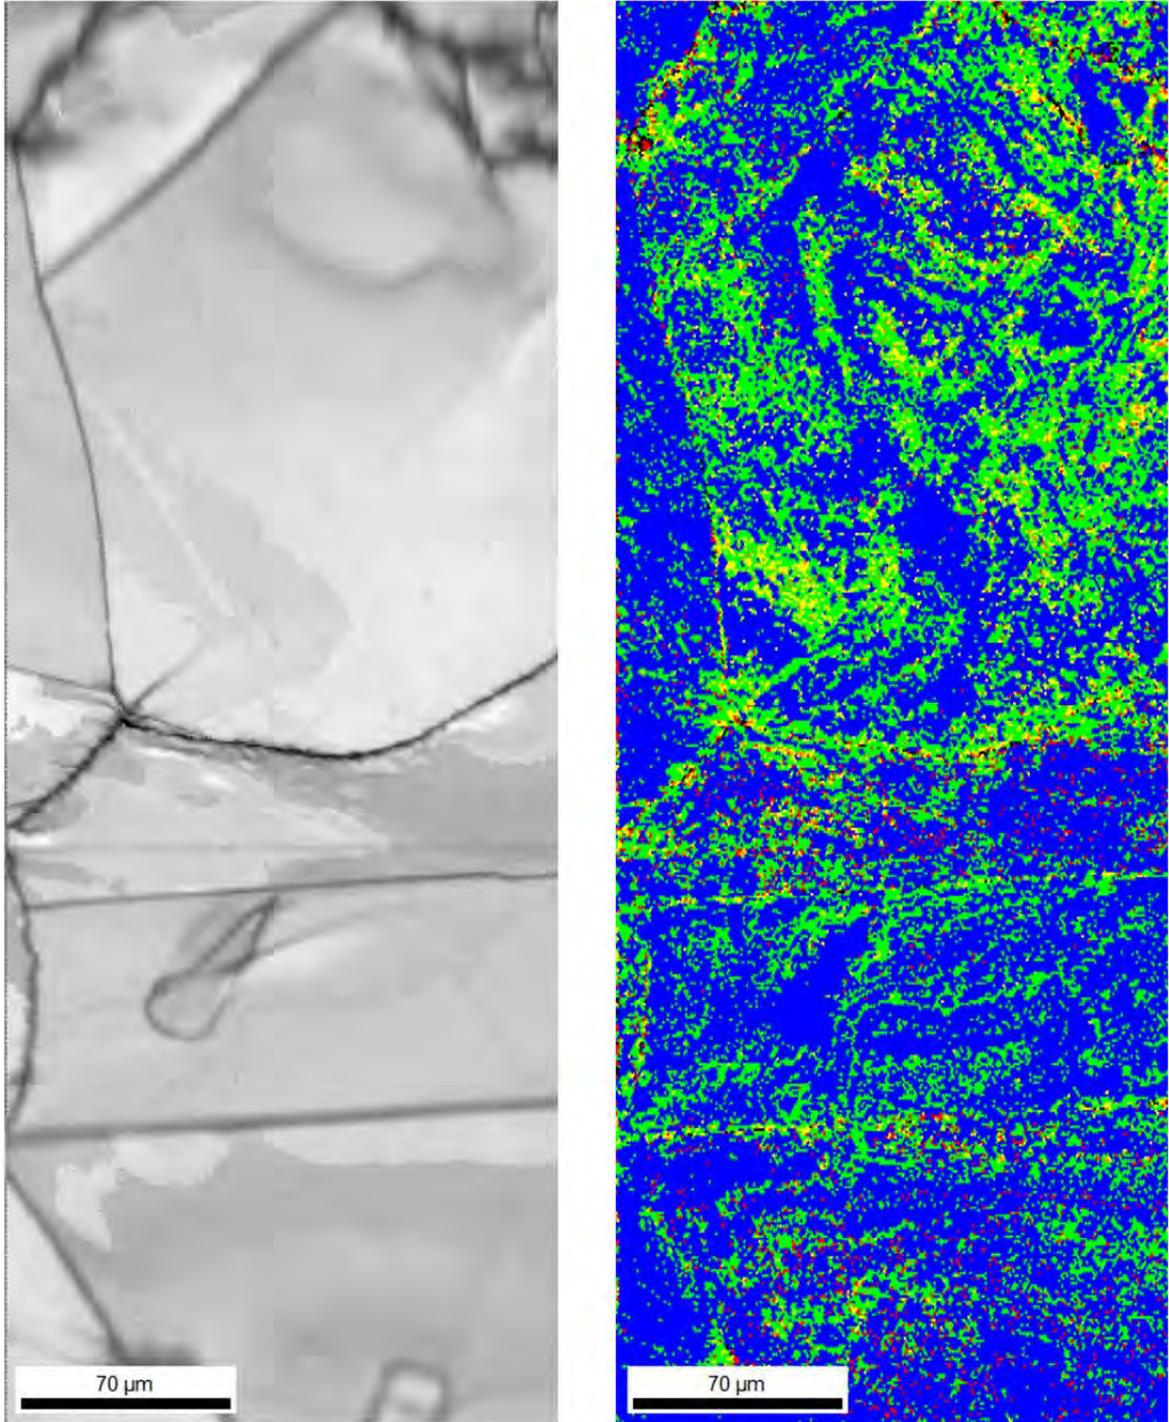
**Figure 57 EBSD mapping of a crack initiation in as-received Alloy 617 tested at 700 °C in helium (Test 8).**

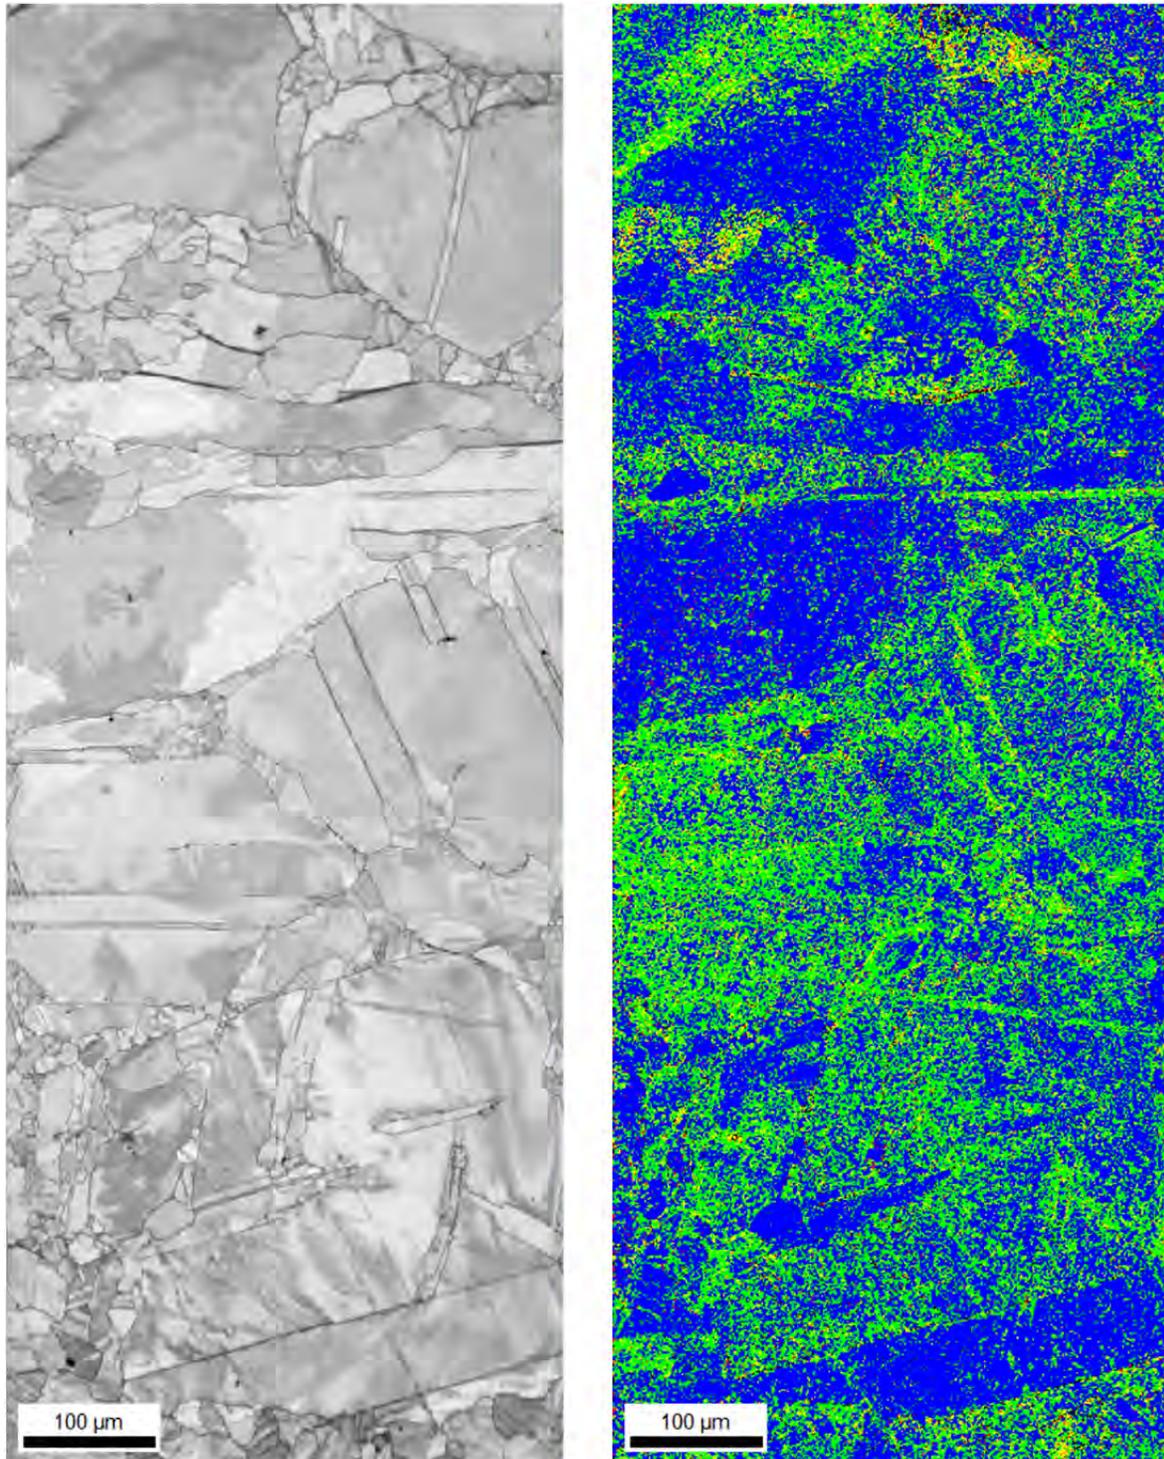
**Figure 58 EBSD mapping of GBE Alloy 617 tested at 700 °C in helium (Test 6). Grains appear to be aligned parallel to the stress direction.**

In the as-received Alloy 617 samples, the grains are significantly smaller than those of the aged samples, and the grains of the GBE Alloy 617 samples are smaller than those of the as-received samples. A thin chromium oxide layer is observed in both the as-received and GBE samples, as is a small amount of an aluminum-rich phase. As was observed in Section 3.3 above, the long axis of the grains is observed to be parallel to the stress direction during testing. Grain size

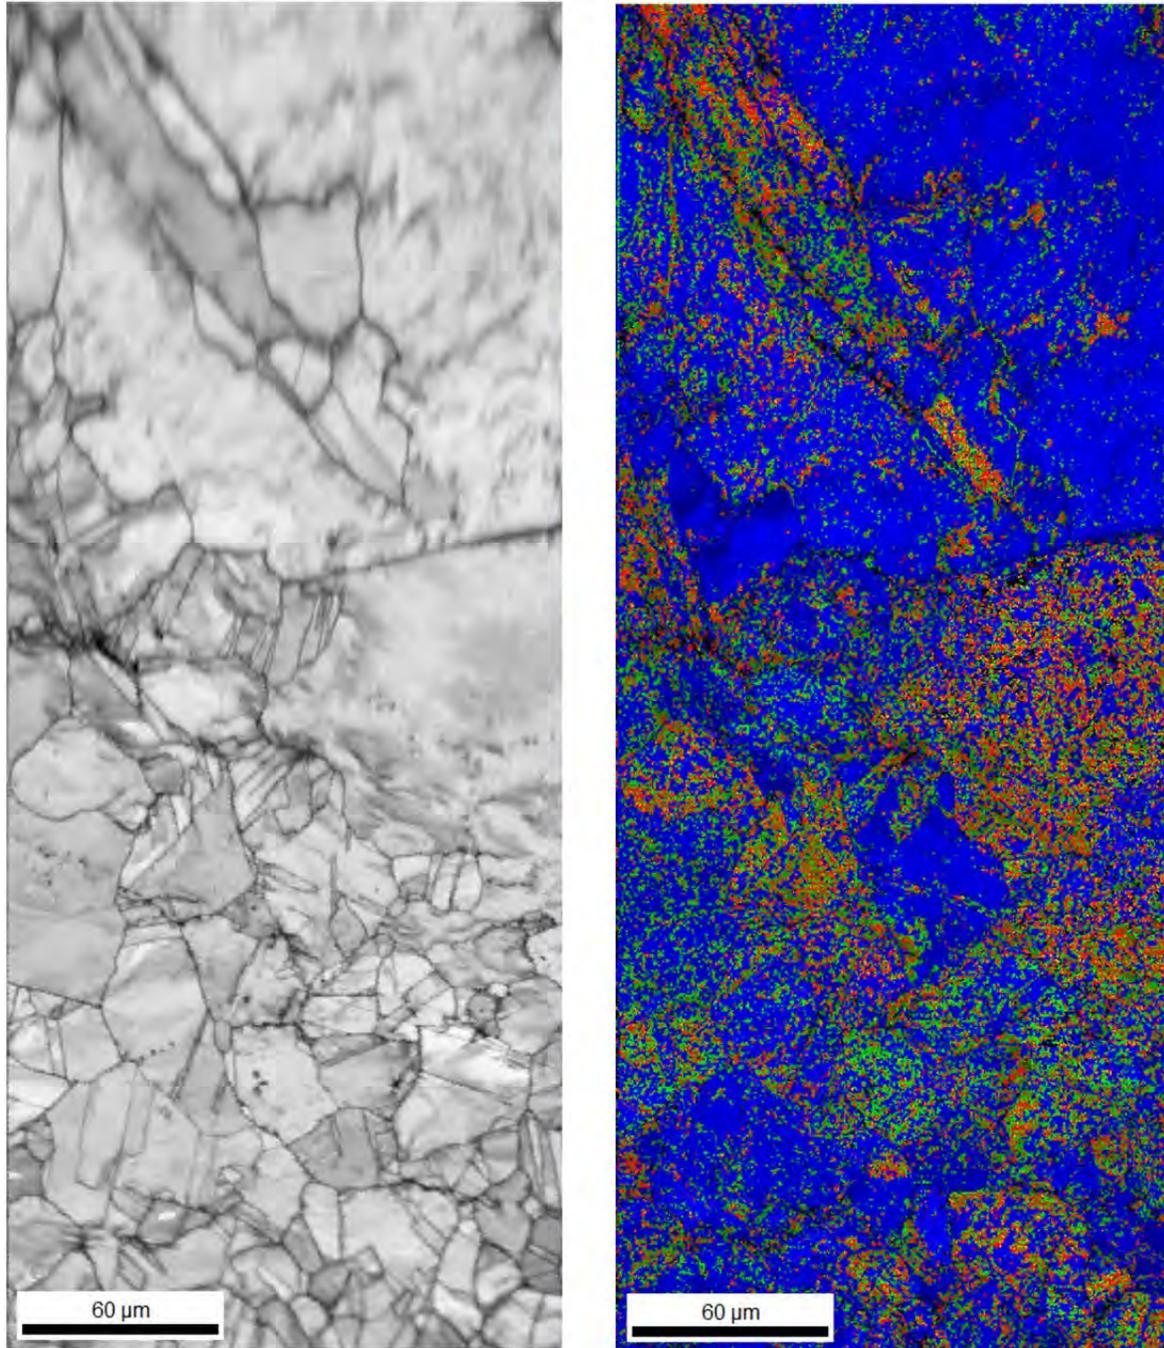
**Figure 59 EBSD mapping of a crack cavitation in GBE Alloy 617 tested at 700 °C in helium. Crack initiation appears to have occurred at a triple point with highest strain.**

Significant strain is observed in the regions near the crack tips (Figure 44 and Figure 46). In general, the cracks appear to have initiated in the grain boundaries with a higher degree of misorientation and strain (Figure 47 and Figure 59).
